# Fly Ash Disposal in Mine Voids and Low-Lying Areas Report of a Field Visit to Bokaro

August 2022

Fly Ash Disposal in Mine Voids and Low Lying Areas  
Report of a Field Visit to Bokaro

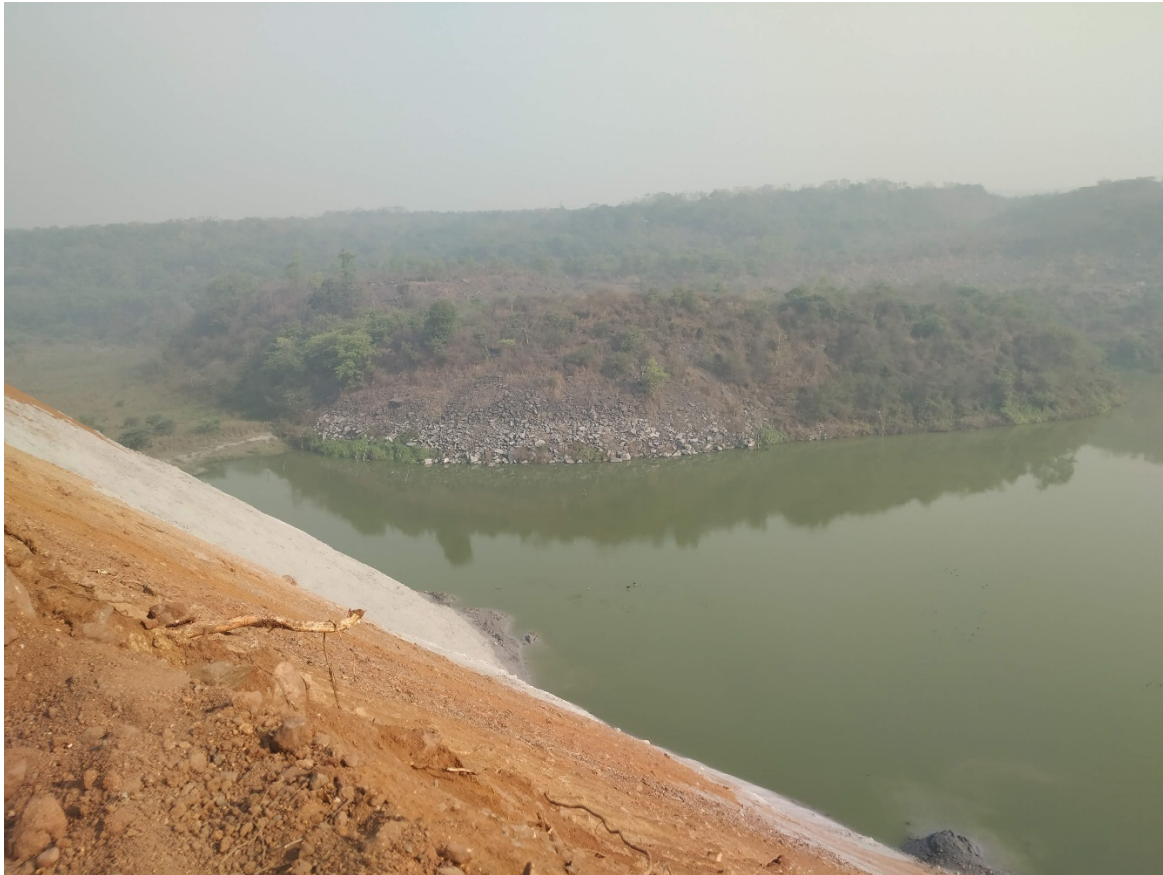
As told to us by the local activists, a segment of this mine void was filled with ash and covered with soil about 7-8 years ago. This segment appears now as compacted, with vegetation growing on top of it.

Figure 2: Quarry 1, Kargali OCP- Newly dumped ash in the mine void and another segment with vegetation on top visible

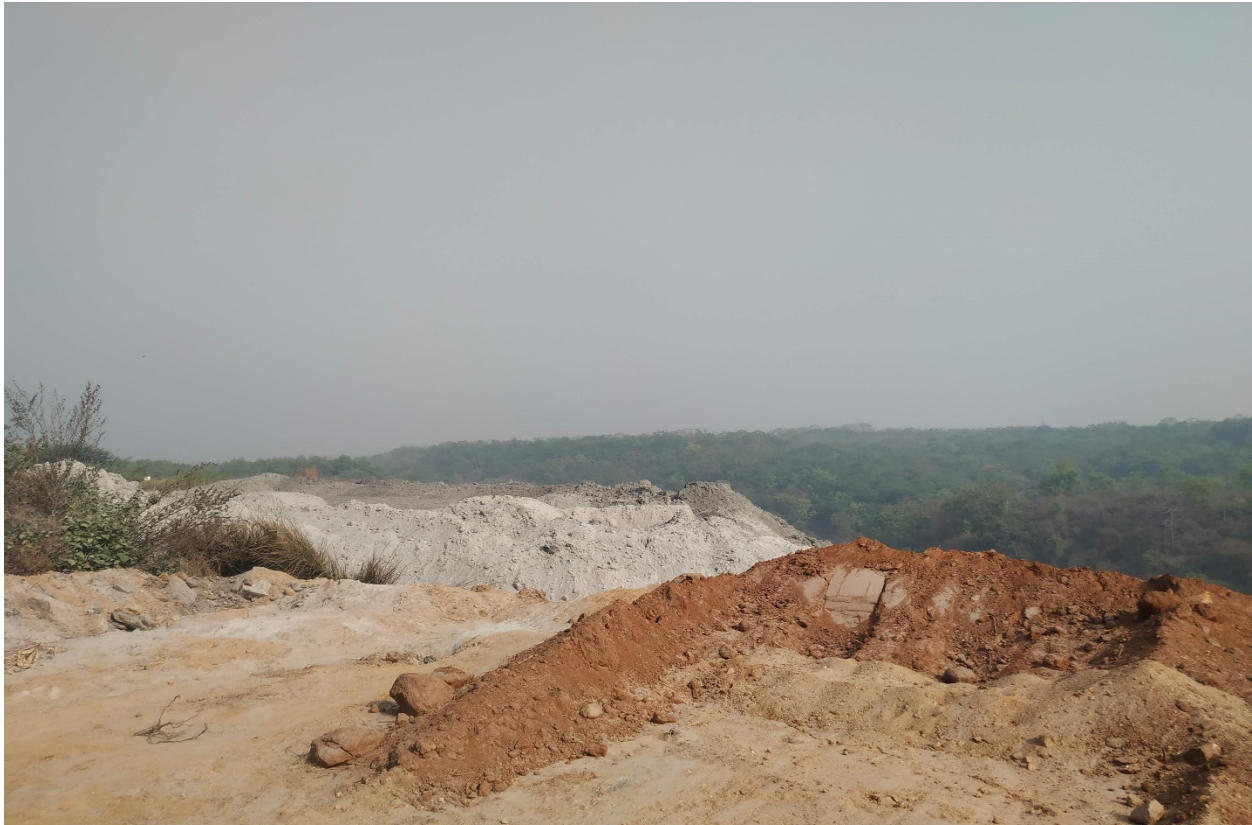
**Figure 3: Quarry 1, Kargali OCP - Mounds of flyash and soil placed along the void**

During the visit, we saw the ash filled trucks arrive and empty the ash in mounds near the edge of the mine void. We also observed the soil dumps nearby. The workers present at the site of filling told us that the first shift of the mine filling at the quarry is from 6 AM to 2 PM, during which, about 70-100 trucks of ash are emptied into it. According to local activist Gulab Chandra, they received permission for the filling in 2019, following a lot of lobbying and DVC and CCL have an MoU. . A worker at the mine void also mentioned that the current ash dumping and soil compaction seem to be carried out beyond the area for which they have permission.

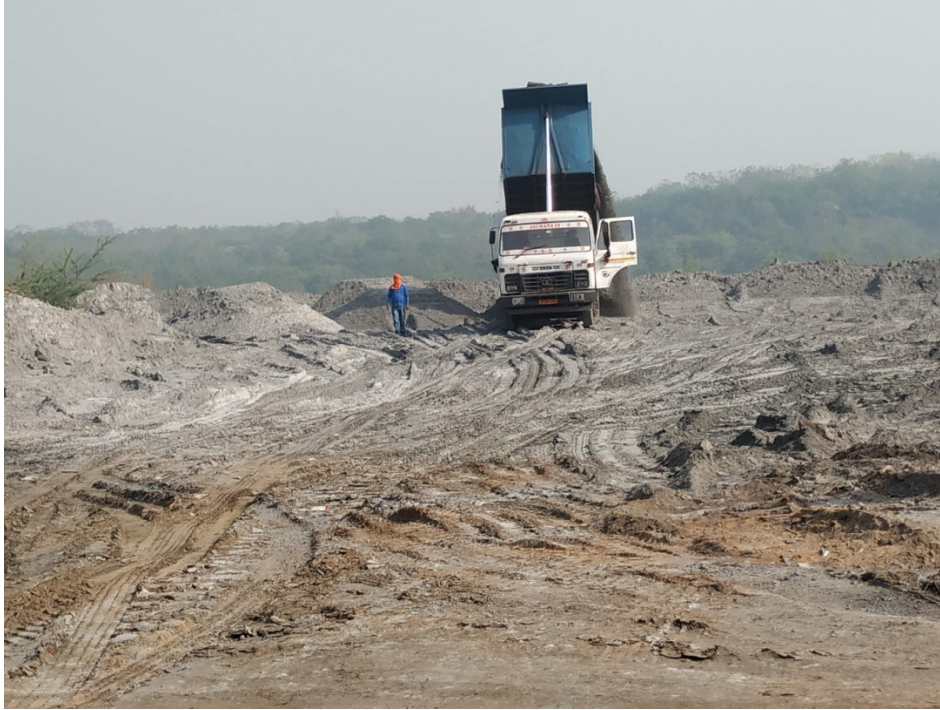
Figure 4: Quarry 1, Kargali OCP - Ash filled trucks unload ash into mounds along the edge of the void

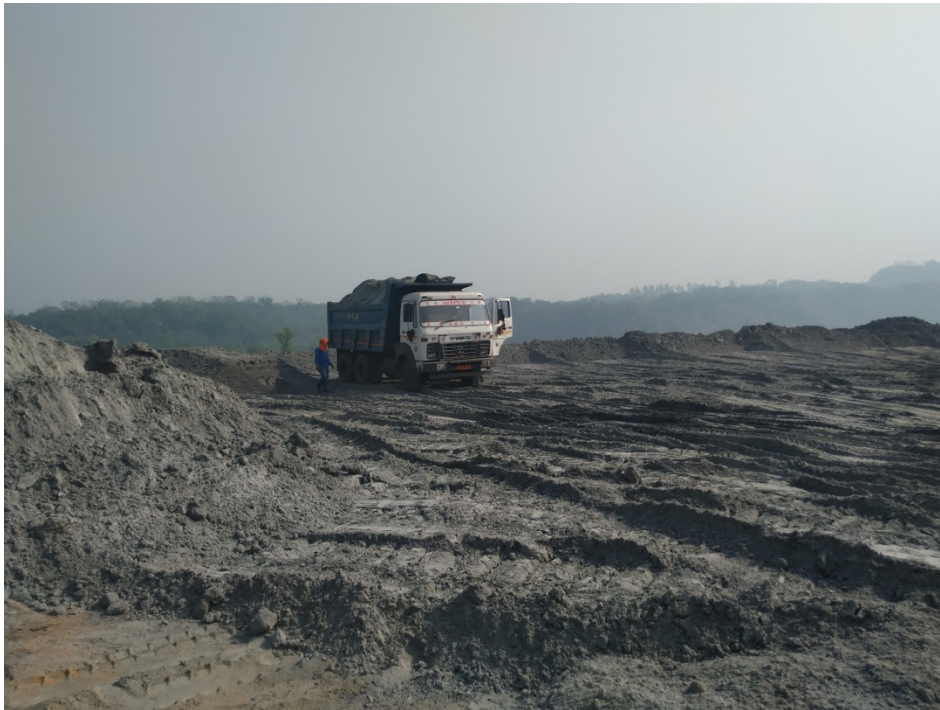
Figure 5: Quarry 1, Kargali OCP-Ash filled trucks unload ash into piles along edge of mine void

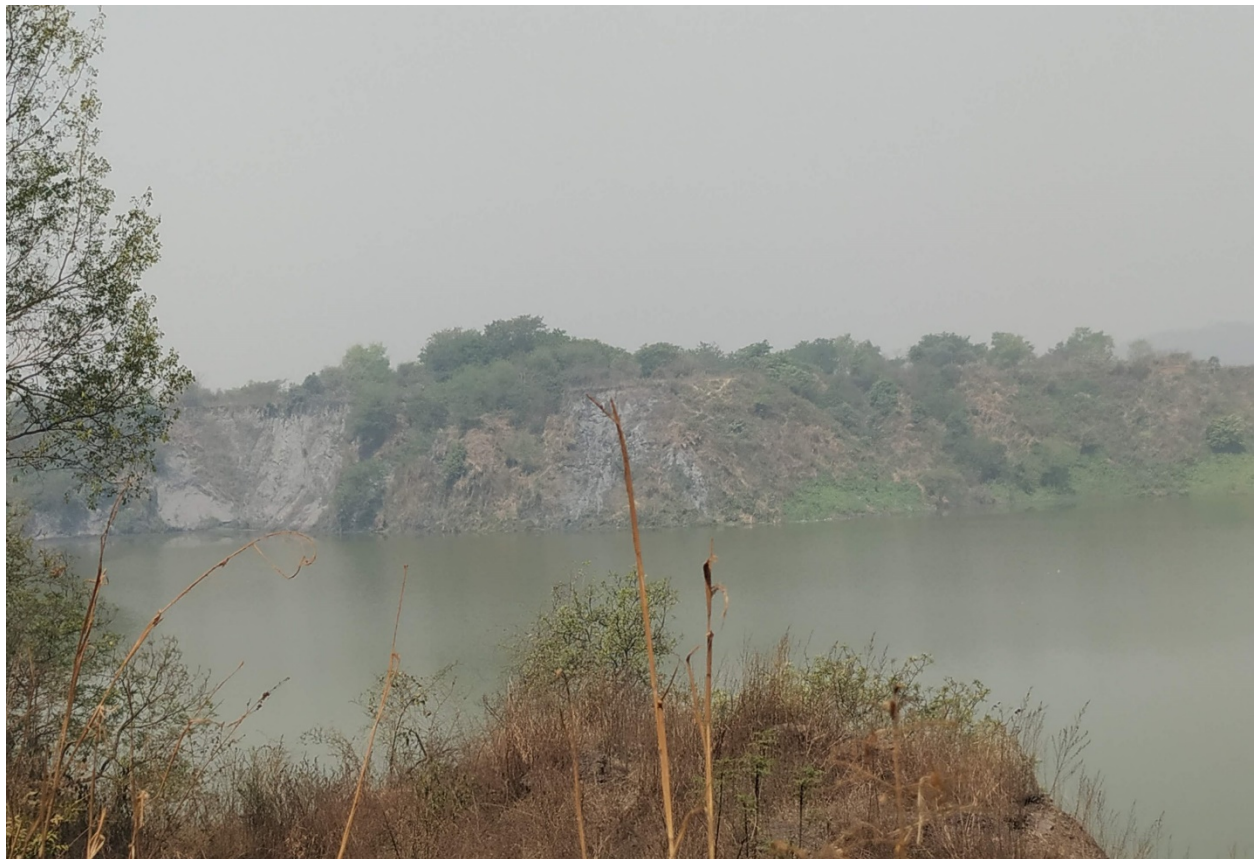
The Bokaro OCP Phase II is located about 1.8 Km kilometers away from Quarry No. 1 of Kargali OCP. One segment of the void has been filled with ash and covered with soil, but the process has stopped several years ago. The void contains large quantities of water, and the local activists told us that the depth of water in the void would be approximately 80 feet.

**Figure 6: Bokaro OCP II - Water in the mine void, ash dump on opposite mine wall visible**

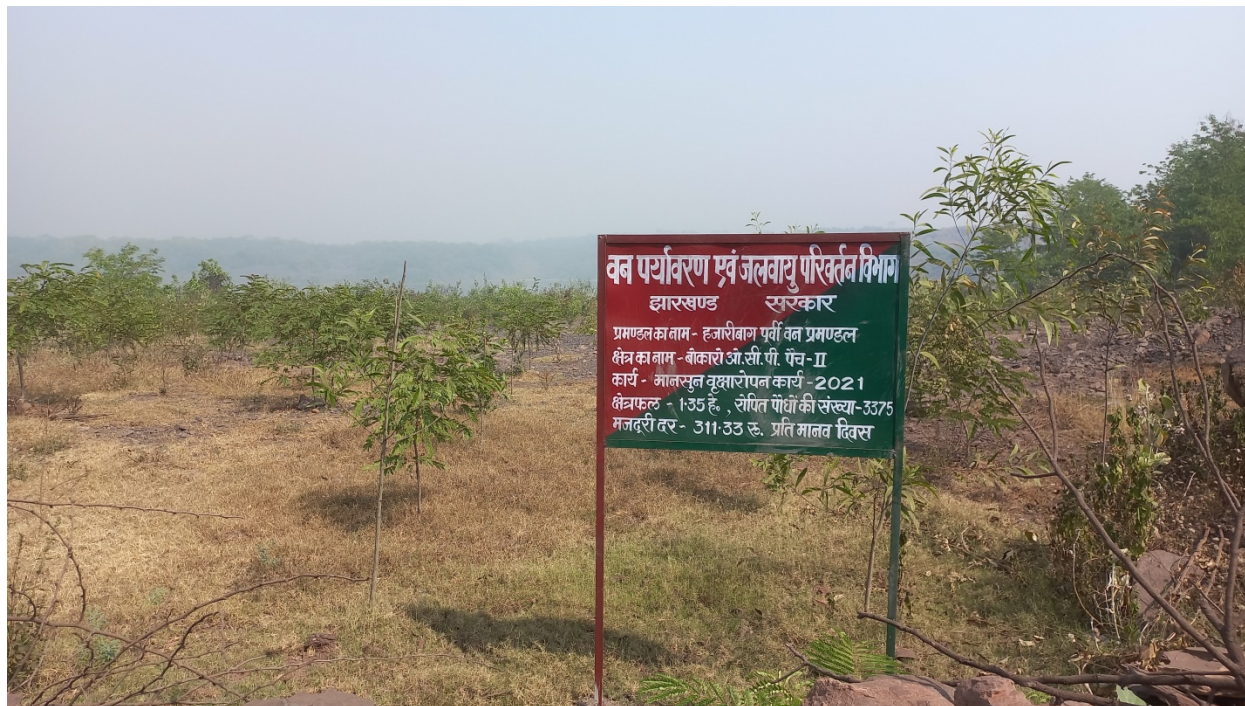
At the Bokaro OCP, we saw that parts of the mine void were filled with ash. One part of these dumps was covered with soil, and plantation had been done about a year back, as per the board put up at the site. However, the plantation was in a bad state and it did not appear that most of the plants would survive.

Figure 7: Bokaro OCP II- Plantation on the top of ash dump

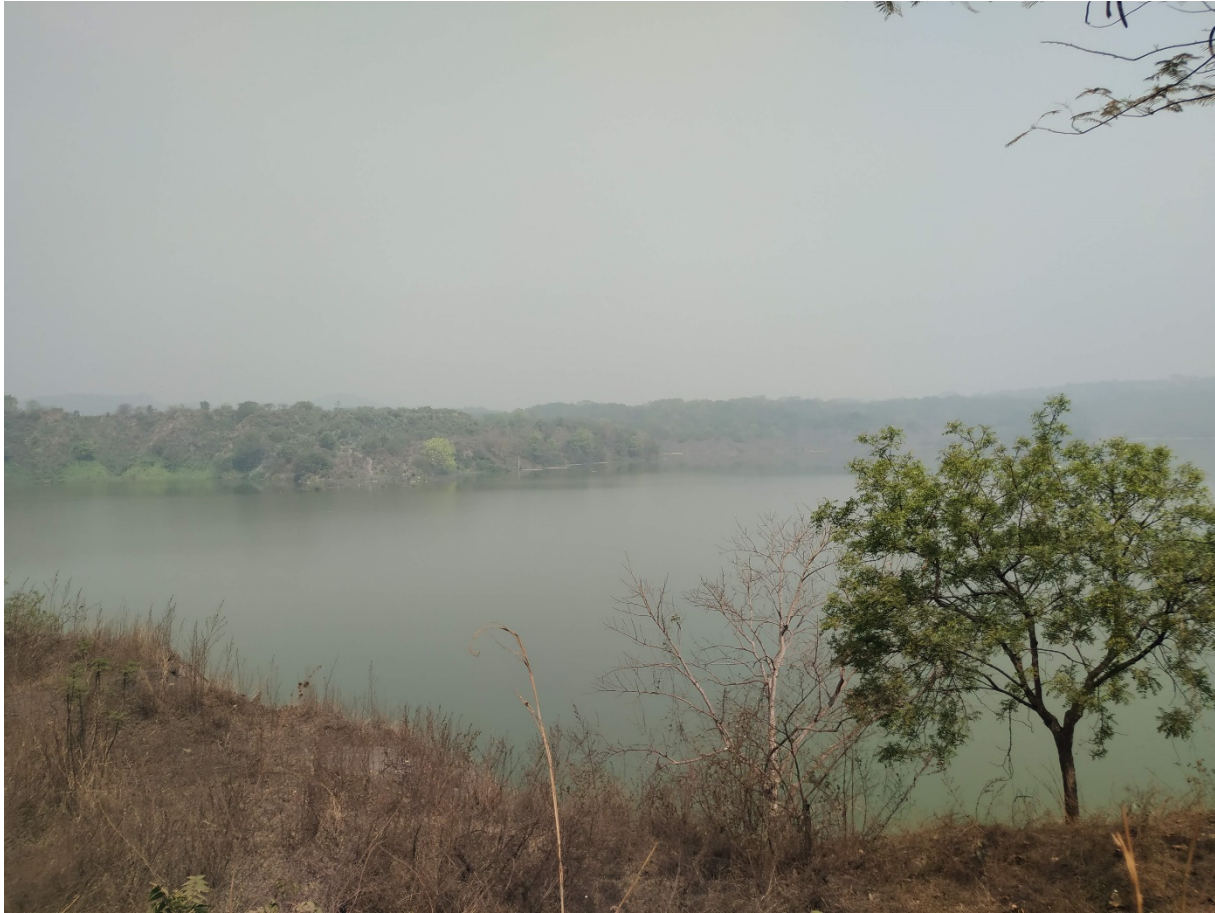
**Figure 8: Bokaro OCP II - Abandoned quarry filled with water, vegetation growing on opposite side**

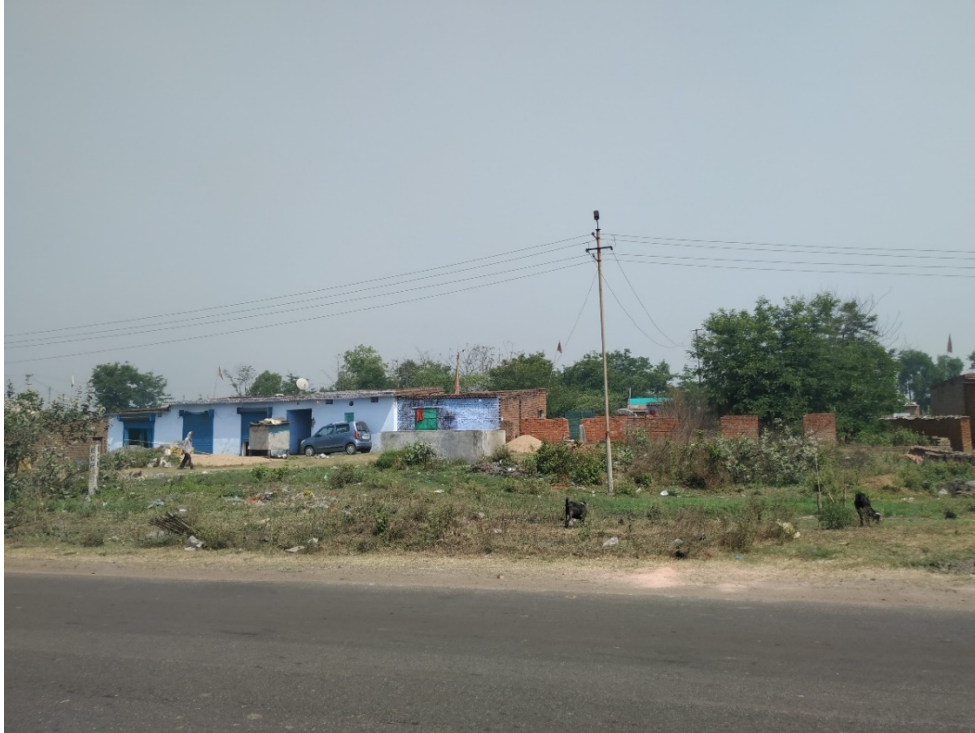
We also briefly stopped at another location of the Bokaro OCP Phase II where ash had been filled in the mine void and then houses constructed on the top of this filling.

Figure 9: Bokaro OCP- Old voids of Bokaro OCP completely 'reclaimed' using ash, houses constructed on top of the filling

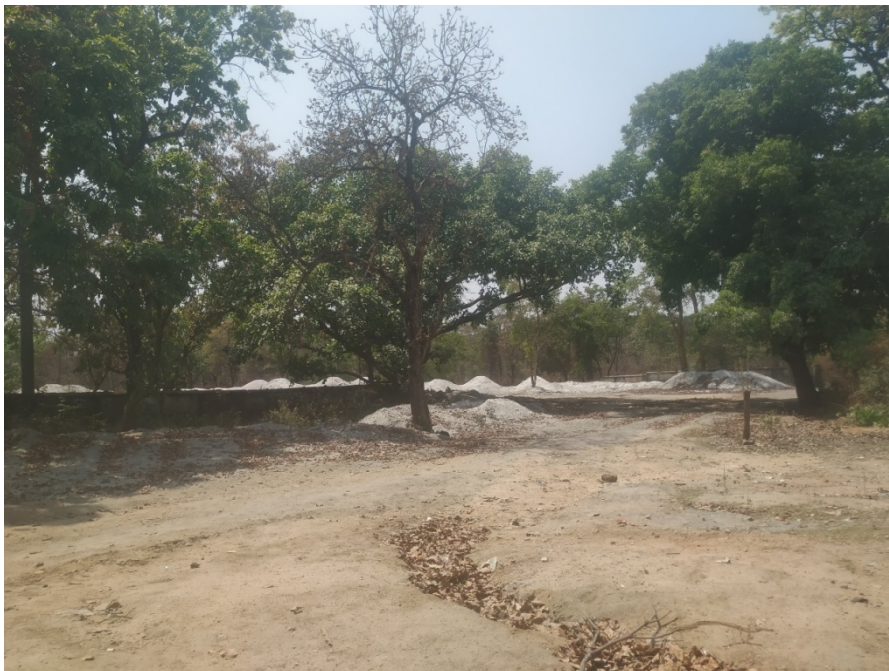
Figure 10: Ash dumps near Konar Dam - Several small to medium dumps can be found on roads around the Konar Dam

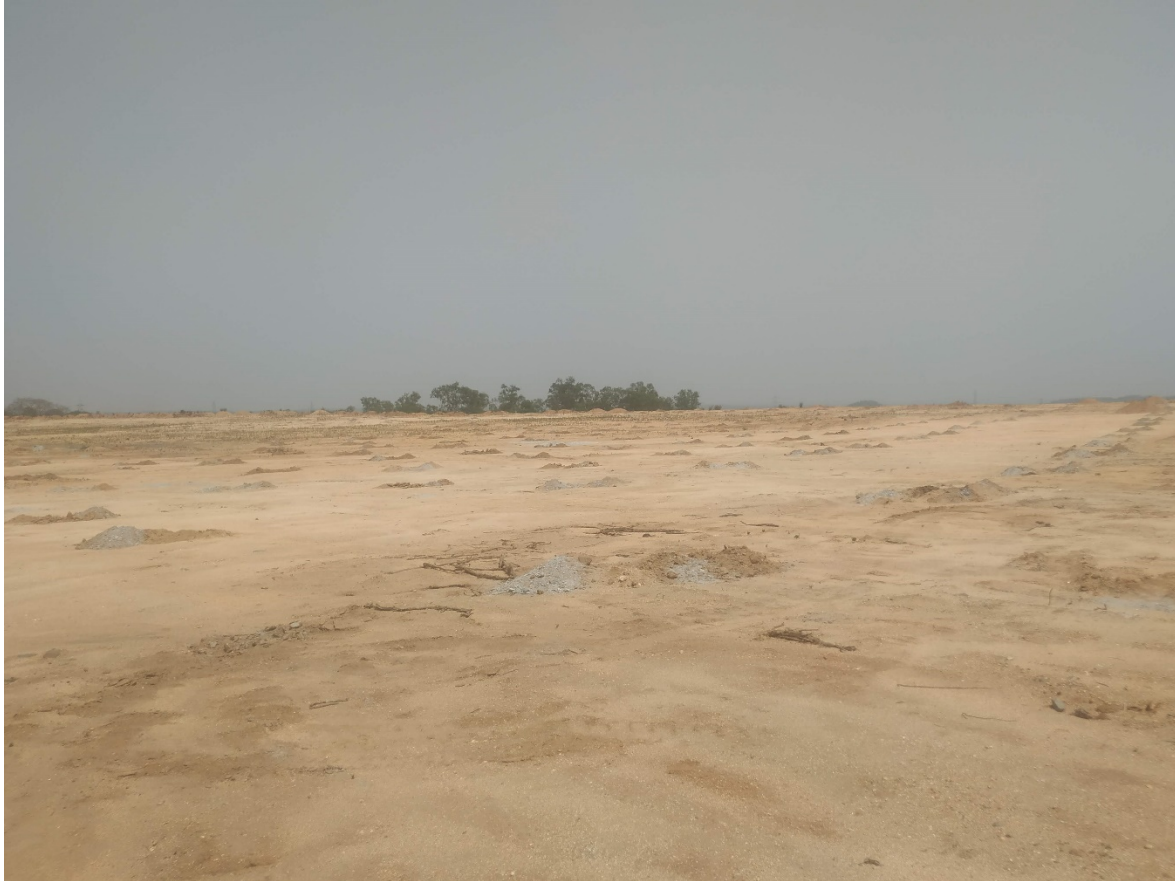
The site visited by the team was a large ash dump, approximately 30 ft. in height (as estimated by us) and spread over 5.76 acres area (measured using Google Earth Pro) It appeared to be an ash dump for 'reclamation' of low-lying land. According to Gulab Chandra, the ash here is also from BTPS. There are old trees surrounding the dump. The way to the dump is lined with old trees throughout, and the ground below the dump (i.e., ground on lower height as seen from on top of the dump) is also covered with trees.

**Figure 11: Ash Dump near Konar Dam -Large ash dump covered with soil, with pits at regular intervals for plantation; photo taken from on top of the dump**

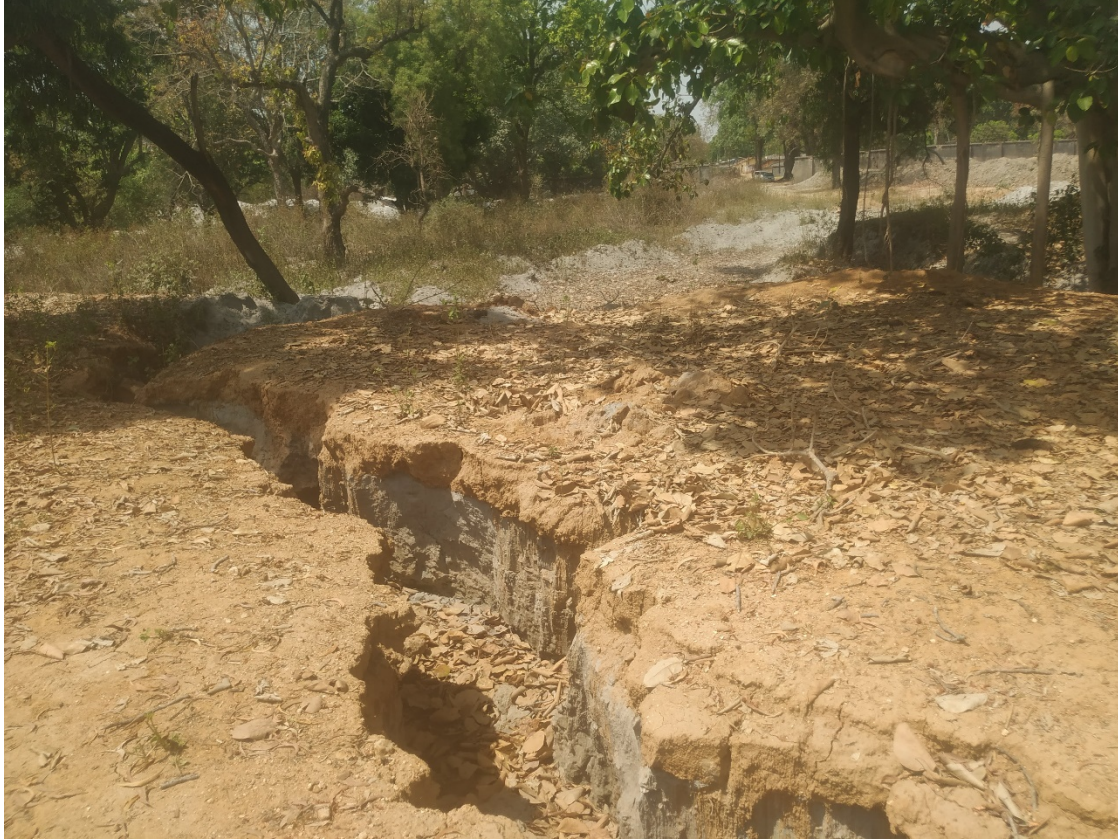
Large quantities of dry flyash were seen dumped across this location. Further, cracks in the ground at one spot revealed layers of ash mixed with the soil. Some piles of newer soil mixed with ash were also visible.

Figure 12: Ash dump near Konar Dam -Cracks in ground reveal layers of ash among layers of soil; flyash piles in the background also visible

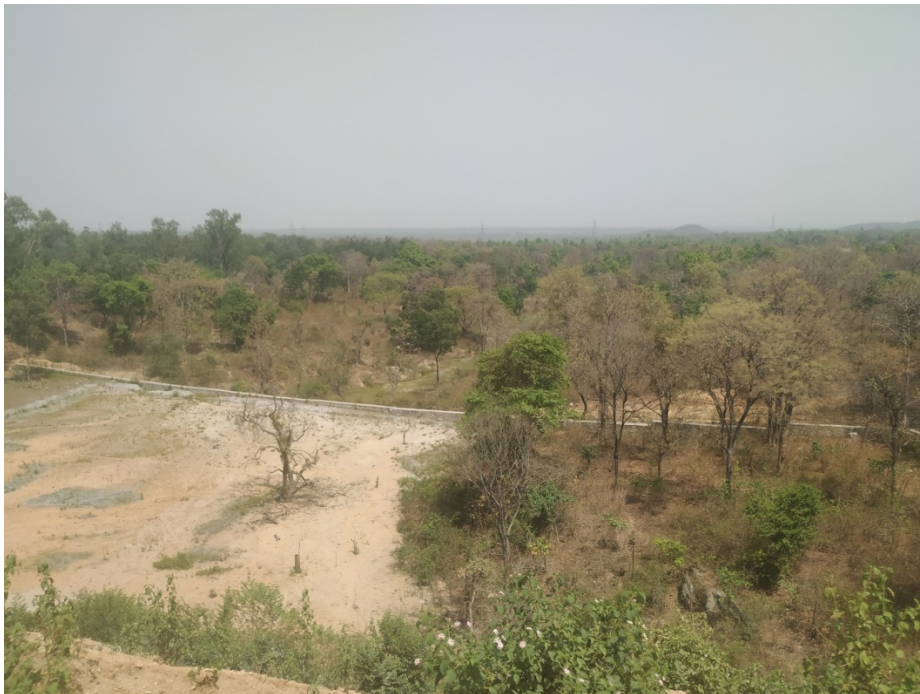
There is a boundary wall that has been constructed along the bottom of the ash dump. This seems to be for preventing ash from being deposited beyond the dump area, or for preventing ash from flowing with rain water into local water bodies. However, ash that has been carried by water flow has accumulated at the wall, and is reaching a height that could soon be more than that of the boundary wall itself. This means it is only a matter of time before the ash laden waters spill over the boundary wall into the local water bodies and local environment. Gulab Chandra mentioned that outside the boundary wall, there used to be a nala flowing through the region. The nala eventually joins Konar, but seems to have been blocked due to the construction of the ash dump. (There was no water visible at the time of the visit.)

Figure 13: Ash dump near Konar Dam- Boundary wall along the edge of the dump at the bottom; ash reaching the level of the boundary wall and trees in surrounding areas also visible

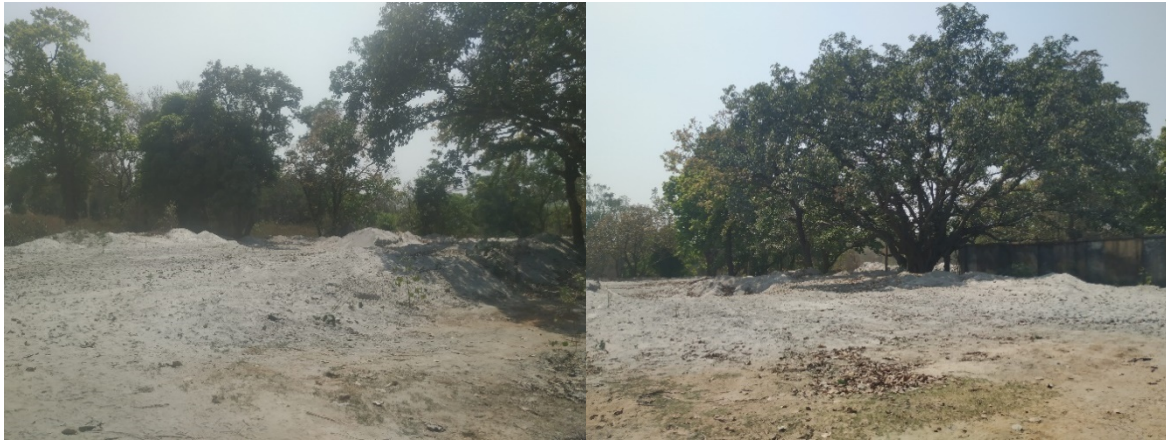
Figure 14: Ash dump near Konar Dam - Piles of ash visible around/on the way to ash dump area near Konar Dam

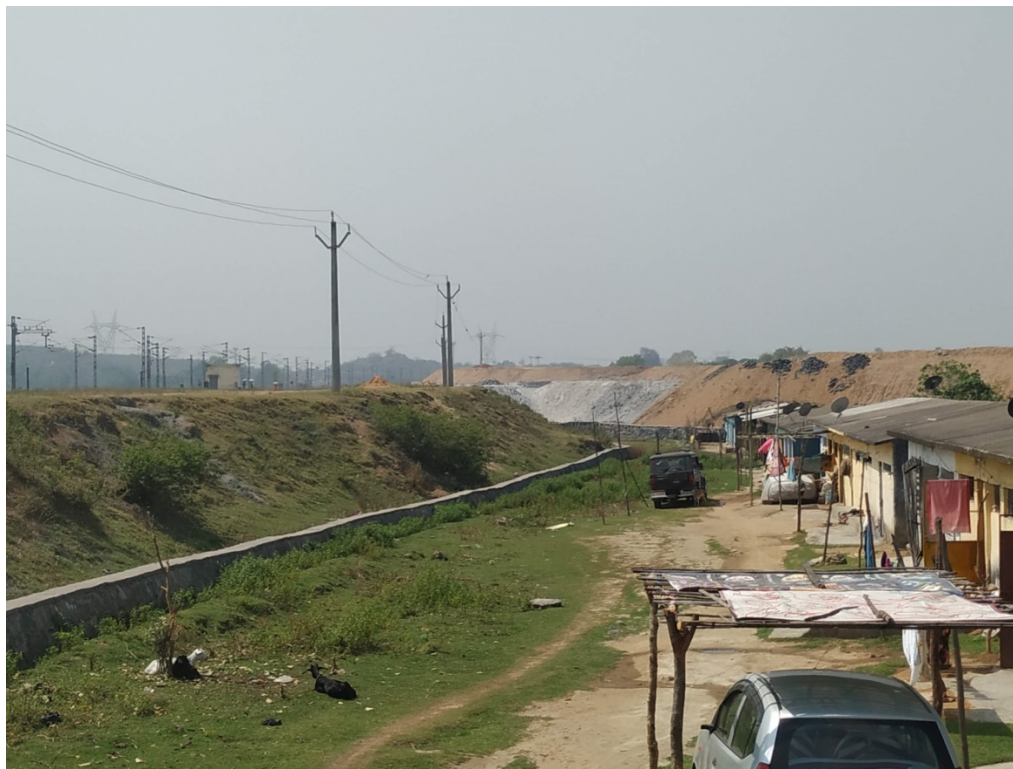
Figure 19: Tenughat Low Lying area ash dumps - Flyash and soil covered ash dump visible near residential buildings

A settlement named *Jhari basti*, located along the railway tracks passing through Lalpaniya, is a settlement surrounded by large ash dumps. The dumping has been done in what is called 'low lying area' by the plant authorities, and appears to be dumped over several years. Where previously people cultivated crops, now there is grass, on land raised about 25- 30 feet above 'ground' level – essentially large dumps of ash covered with soil. Old ash dumps that have been covered with layers of soil can be seen on either side of the railway tracks, and are less than 1 Km from residential buildings.

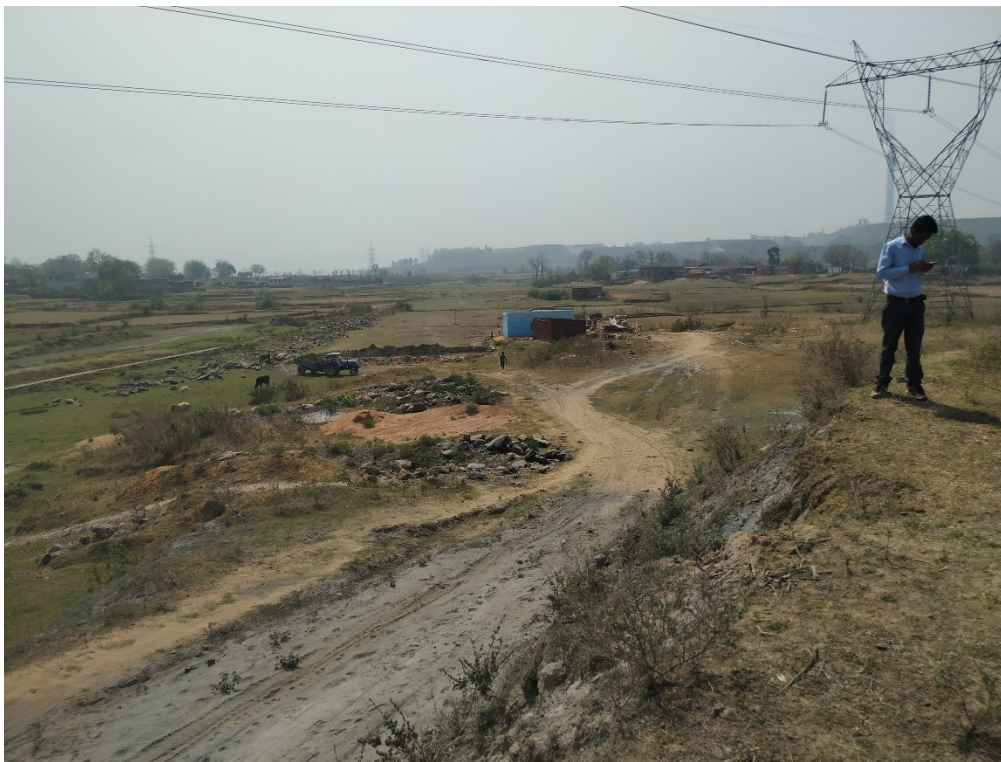
Figure 20: Tenughat Low Lying area ash dumps - Ash laden road on the way to Jhari Basti; photo taken from on top of ash dump

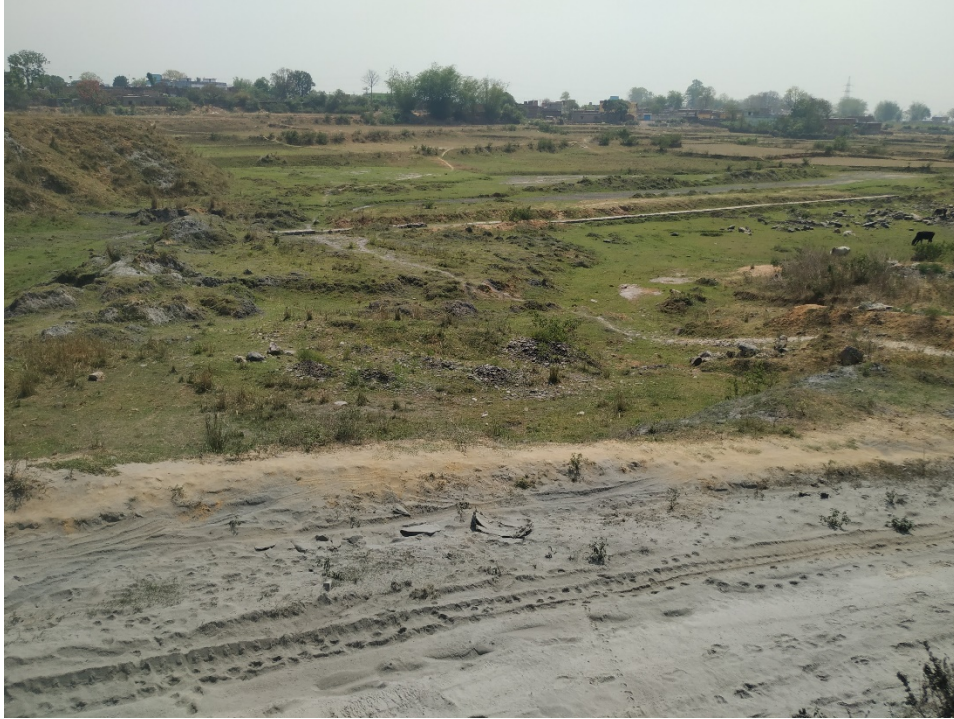
Locals of Jhari basti mentioned that a lot of agricultural land has been ruined by ash dumping over the years. Even when plant authorities have tried to clear some amount of ash the effort seems ineffective because – as we saw at the site- ash is ever present. There are about 15-20 houses on one side of the railway line, with families who have been living there for over a decade and have experienced the impacts of excessive flyash dumping all around their land. They say that the ash dumping has made their land non-cultivable, '*banjar*', over time, and that they haven't been able to successfully farm for 3 years now, the time from when the ash dumping started near their basti. Satellite imagery over the years also shows that the ash dumping that was visible also began in this location little over 3 years ago. Airborne flyash from ash mounds located few kilometers away as well the local dumps settles on the standing crop, which has adversely affected the crop yields. Ash also settles across the village on people's homes, vehicles, water storage materials etc. Ash has even deposited in the village well. 3-4 buffalos have died after getting stuck in the ash slurry during monsoon time. When it rains, the ash mixed with water flows and eventually makes its way to the Tenughat reservoir. About 12-13 families have been resisting the impact of pollution on their lives by writing to local authorities (SDO), but they have not received relief so far.

**Figure 21: Tenughat Low Lying area ash dumps-Ash routinely covers the grazing land in vicinity of Jhari Basti**

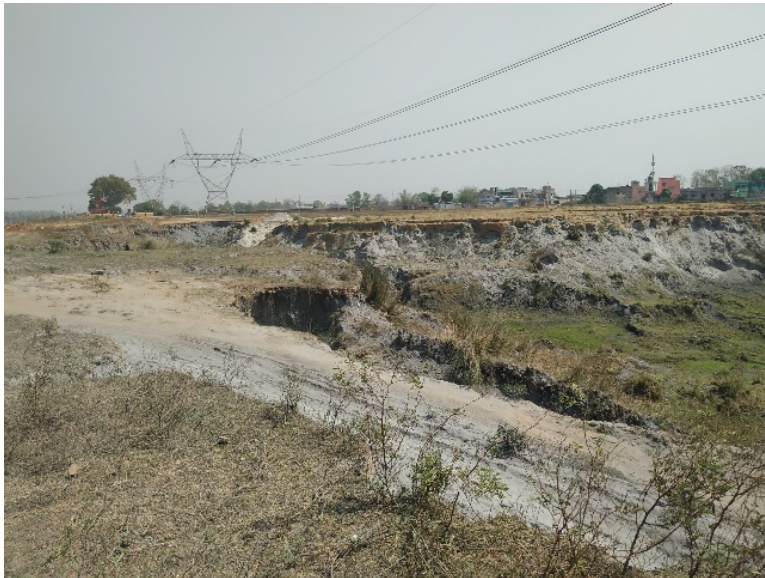
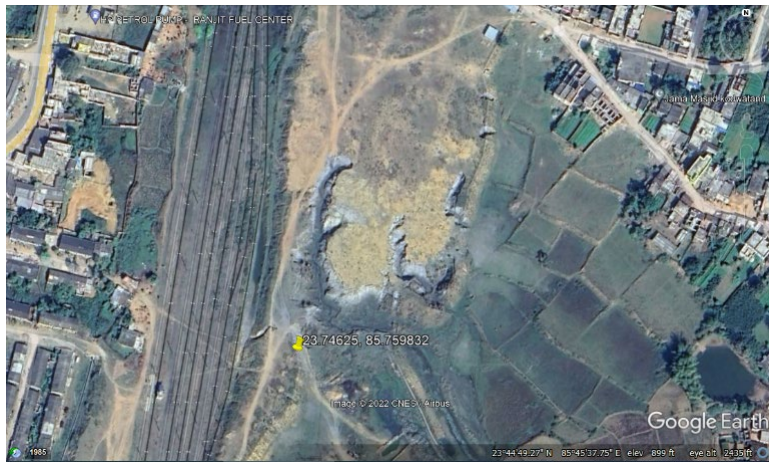
**Figure 23**

**Figure 22: Tenughat low lying are ash dumps - Photograph of large ash dump near Jhari Basti above; Satellite Image of same ash dump below (Figure 23)**

It should be noted that the objective of filling up low lying area with ash is typically to fill an area which is in lower elevation to bring it to the surrounding ground level. However, the dumps seen by us at Lalpaniya seemed to be large dumps jutting out above ground level.

*“These waste dumps shall be immediately removed and kept in a controlled pond. TVNL authorities shall strive for utilization instead of open dumping. Otherwise, construct an ash dyke and store it to prevent leakage.”*

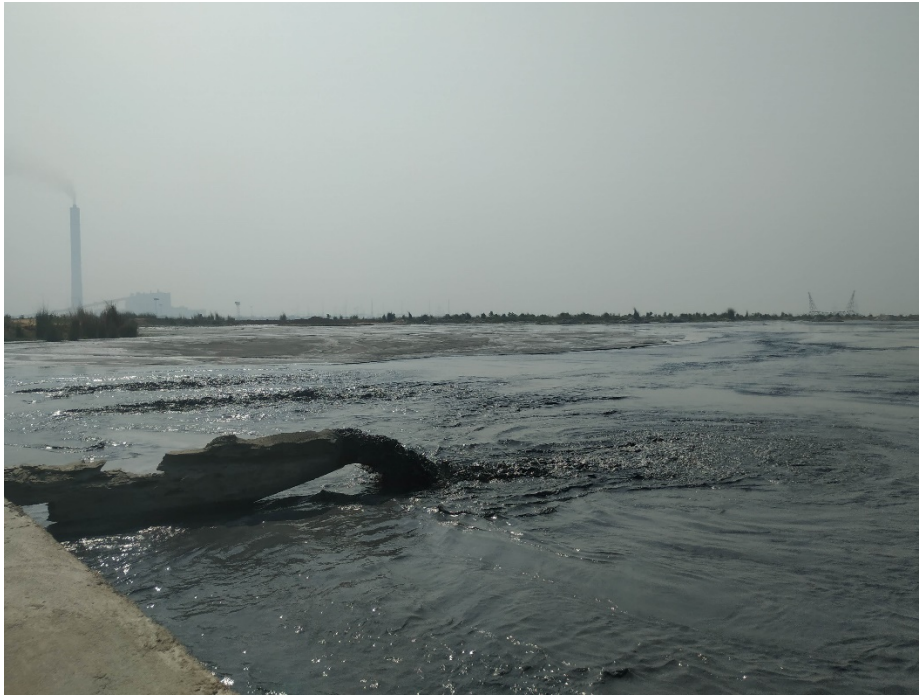
The team also visited the TTPS ash pond. We found ash slurry being disposed of in the ash pond in one part. At another part, we also saw pond ash being removed and taken away in trucks. We were told that

Figure 27: TTPS Ash Pond - Ash slurry flowing into pond, TTPS chimney visible in background

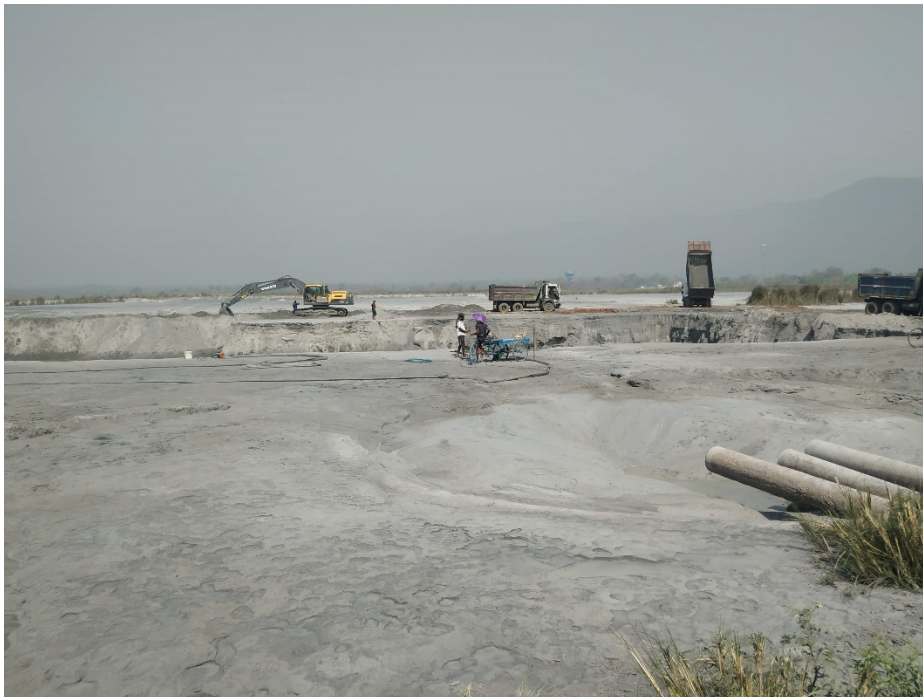
Figure 28: TTPS Ash Pond- Trucks stationed for loading with flyash at one section of ash pond

We observed that some of the trucks were transporting ash without the mandated covering.

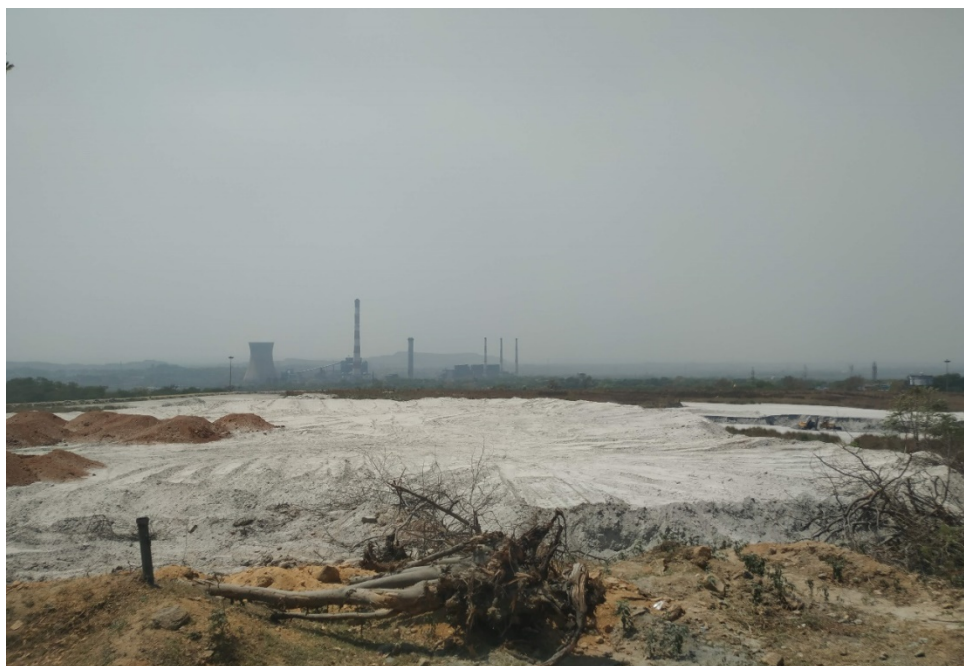
The ash pond of DVC owned Bokaro Thermal Power Station breached in September 2019 flooding 20 DVC quarters and nearby farmland with ash slurry. According to local residents of the villages surrounding the ash pond, at least 45 acres of agricultural land was flooded with slurry. The official cause of the breach stated by MoEFCC in its site visit report was hydraulic pressure induced by heavy rainfall. However, locals from the villages surrounding the ash pond (Nurinagar, Bazar Tand, Jarwa Basti) contested the claim, stating that the pond had been too full and fear of a breach had been growing for months before it actually happened. We spoke with locals in Bazar Tand, and a senior villager told us he had still not been compensated for the damage caused by the ash slurry breach to his standing crop (rice). Parts of his agricultural land, and that of several others cannot be used like it was before, as it was not adequately cleaned in the aftermath of the breach – all this over two years after the incident occurred. Even routine ash transport causes havoc for residents living less than 1 Km from the ash pond. The locals mentioned that ash carrying trucks pass through their village throughout the day, covering the terraces of all homes in a 1 inch layer of ash. Even though they clean their houses in the morning, by the evening, the house floors and insides also get covered in ash.

**Figure 29: BTPS Ash Pond - One section of ash pond with BTPS visible in background**
