Fly Ash Disposal in Mine Voids and Low-Lying Areas

Report of a Field Visit to Bokaro

Summary

August 2022

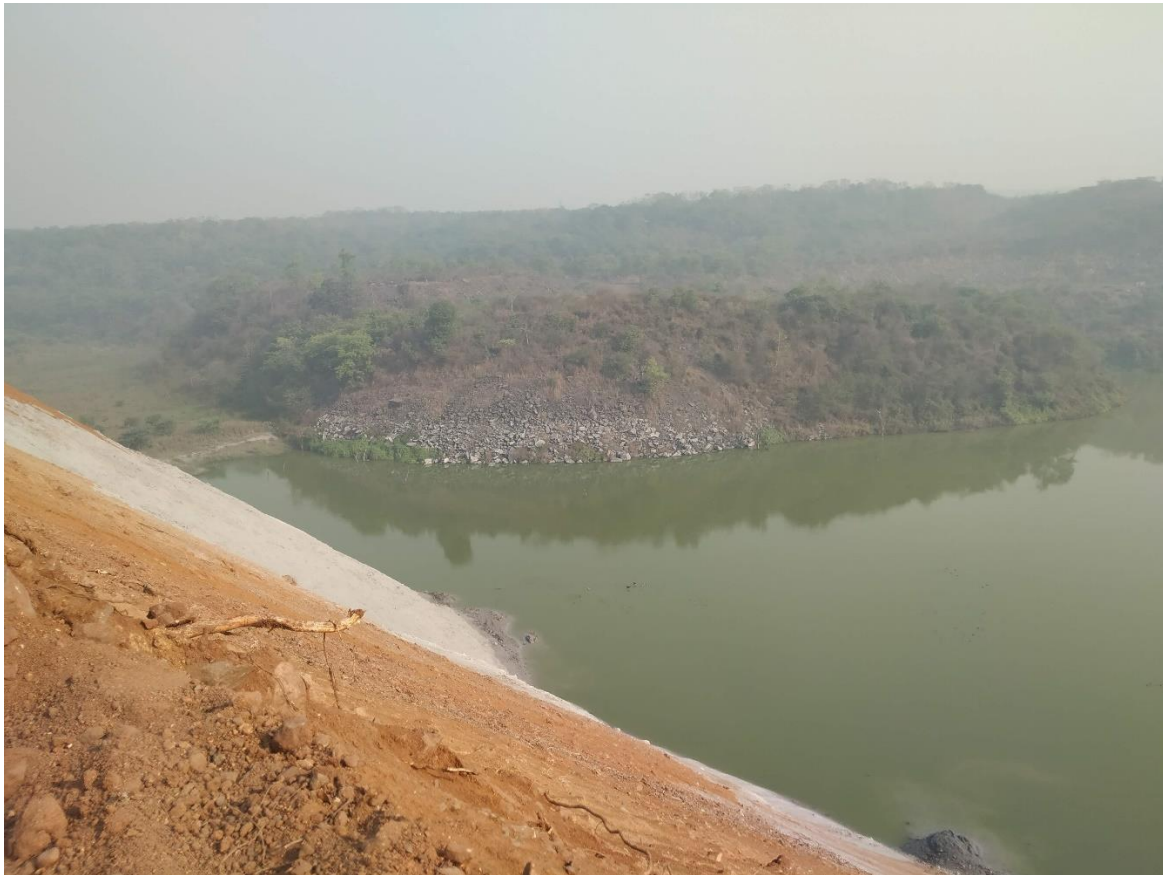
Quarry No. 1 of Kargali OCP is located approximately 0.5 km away from Ram Vilas High School in Bermo, Bokaro district. It has been non-operational for some years now, and its quarry 1 is filled with water. As told to us by the local activists, a segment of this mine void was filled with ash and covered with soil about 7-8 years ago. This segment appears now as compacted, with vegetation growing on top of it.

Figure 2: Quarry 1, Kargali OCP- Newly dumped ash in the mine void and another segment with vegetation on top visible

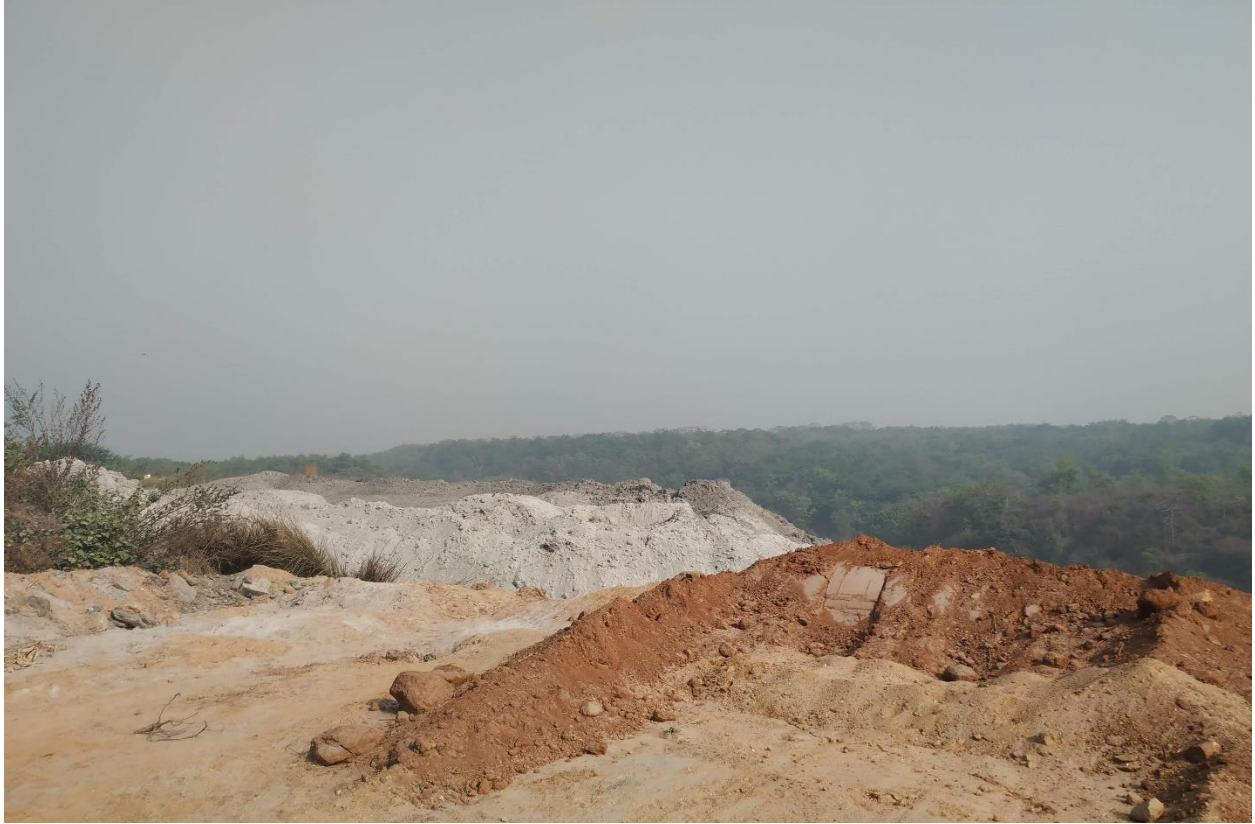
The other segment of the void is currently being filled with flyash from DVC's Bokaro Thermal Power Station (BTPS). We saw the mine being filled with ash. Ash is brought to the mine in covered trucks, after which, the covering is removed, and ash in dry form is directly dumped into the section being reclaimed. The section of the mine being filled is an almost 45 m strip from the edge of the mine. The ash is dumped into the depths of the mine and then as the dumping reaches the surface, a layer of soil is put on the top of the ash. We were told the ash has been dumped here since the last two years.

Figure 3: Quarry 1, Kargali OCP - Mounds of flyash and soil placed along the void

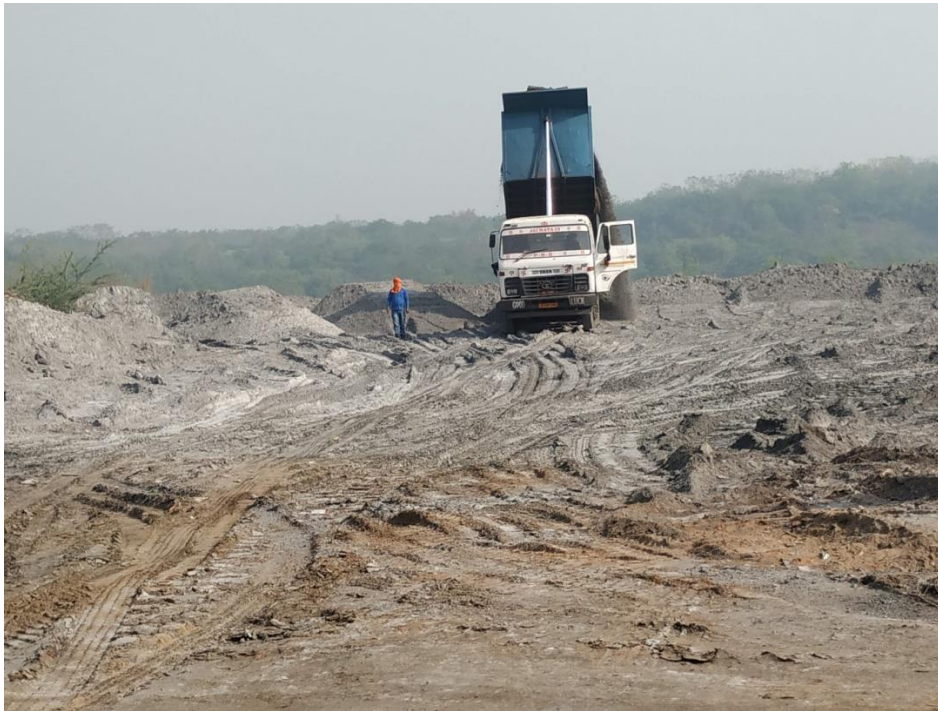
Figure 4: Quarry 1, Kargali OCP - Ash filled trucks unload ash into mounds along the edge of the void

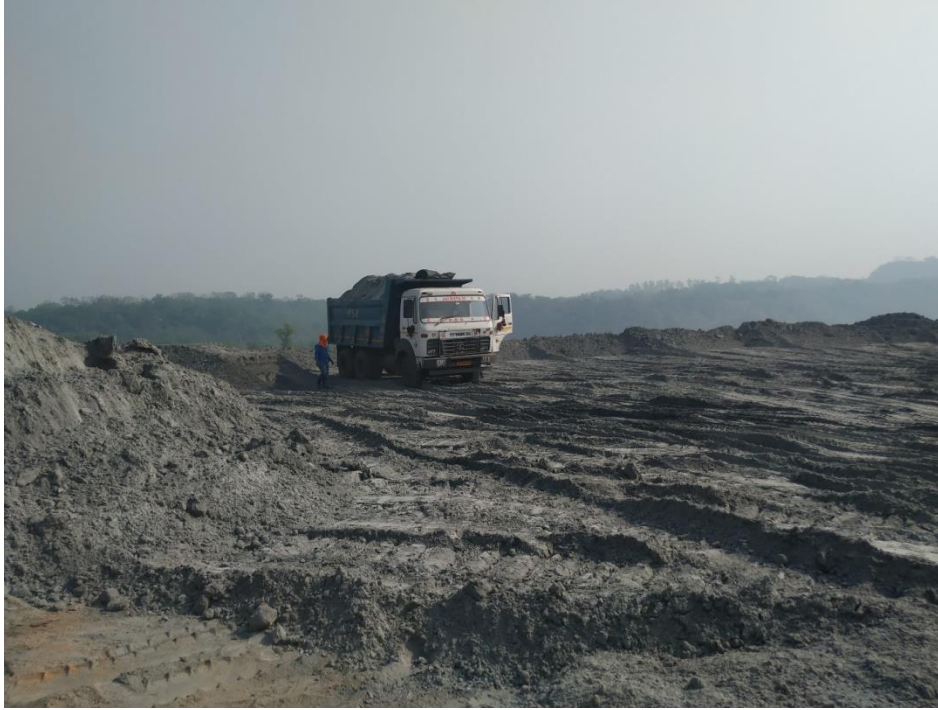
Figure 5: Quarry 1, Kargali OCP-Ash filled trucks unload ash into piles along edge of mine void

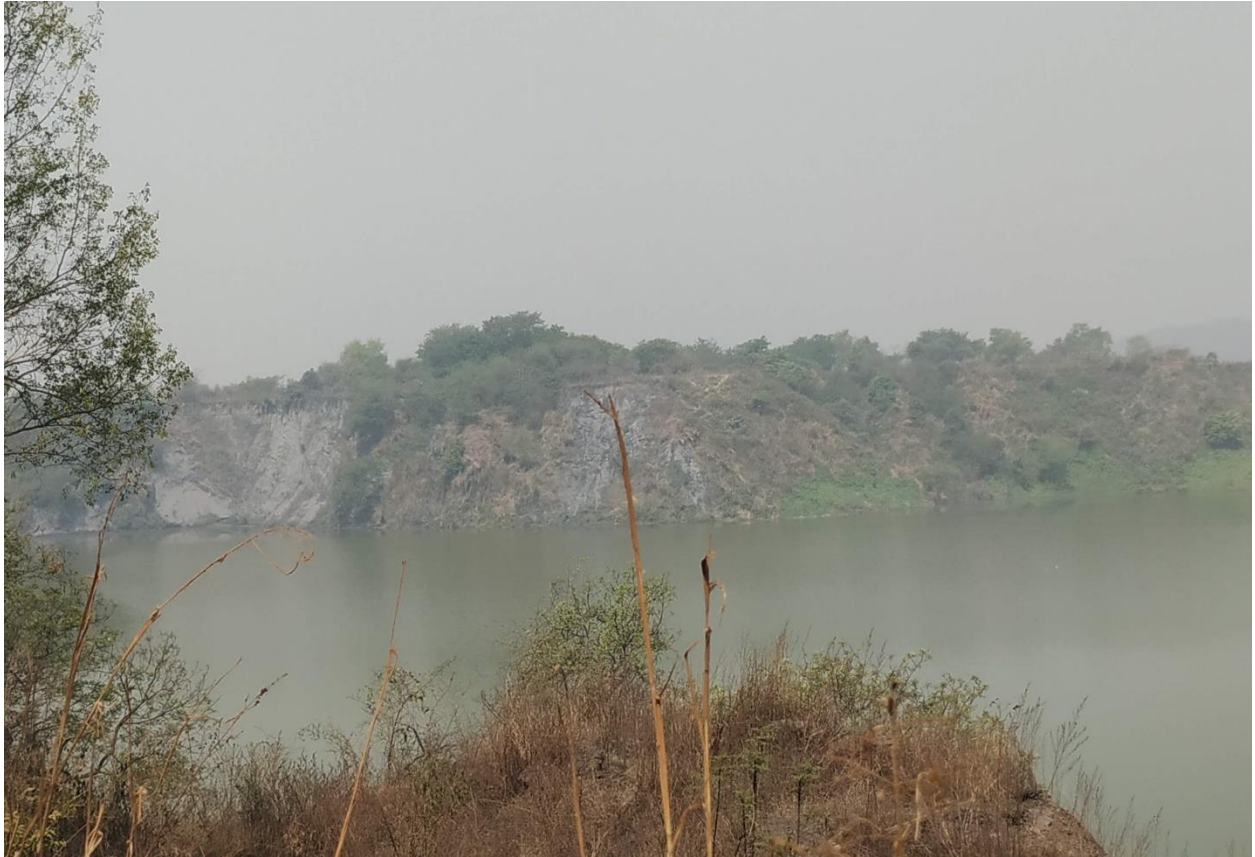
The Bokaro OCP Phase II is located about 1.8 Km kilometers away from Quarry No. 1 of Kargali OCP. but the process has stopped several years ago. The void contains large quantities of water, and the local activists told us that the depth of water in the void would be approximately 80 feet. One segment of the void has been filled with ash and covered with soil, and plantation had been done about a year back, as per the board put up at the site. We were told that the species planted were *Acacia* and *Chakaundi* (local names) as well some *sheesham* and *amla*.

Figure 6: Bokaro OCP II - Water in the mine void, ash dump on opposite mine wall visible

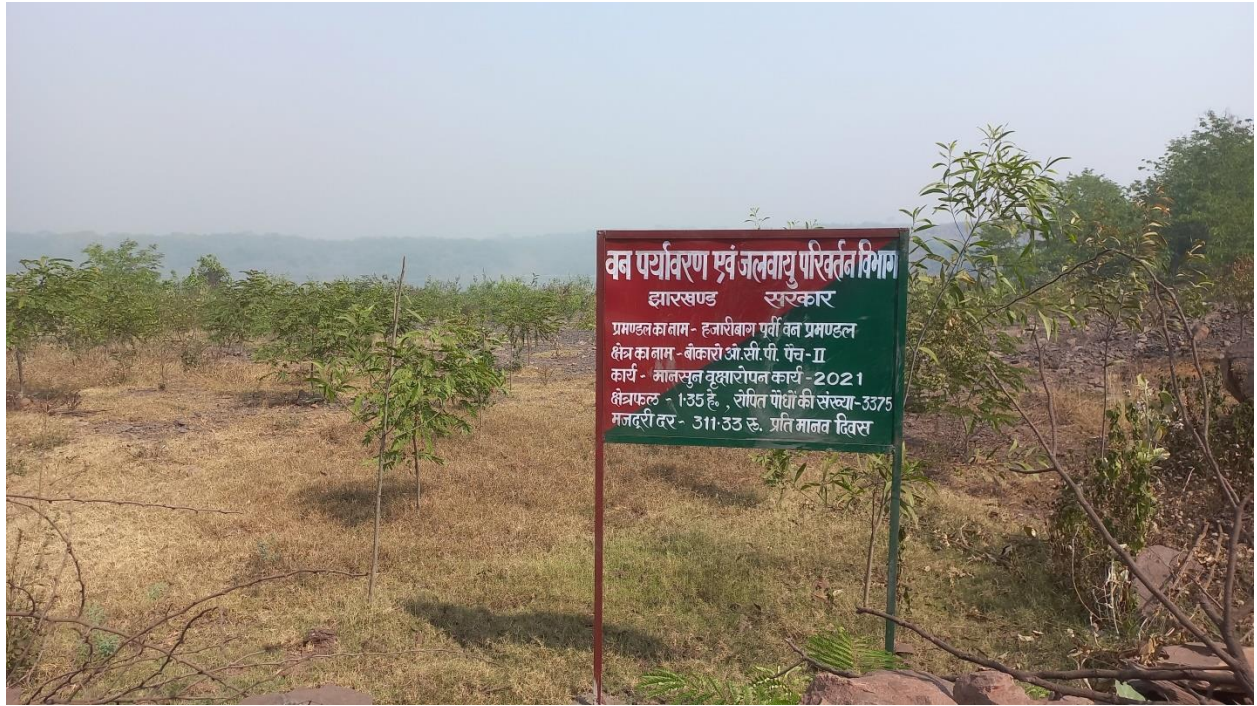
Figure 7: Bokaro OCP II- Plantation on the top of ash dump

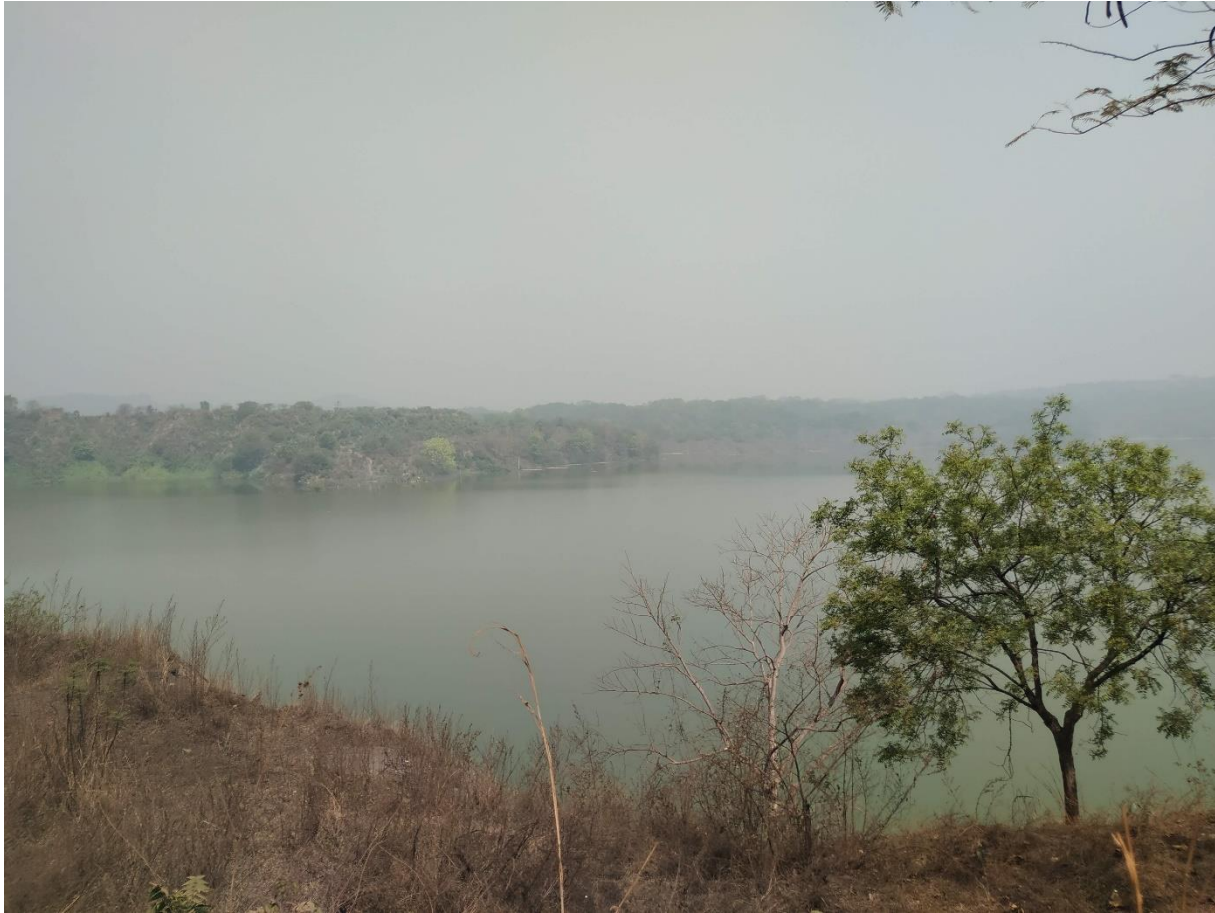
Figure 8: Bokaro OCP II - Abandoned quarry filled with water, vegetation growing on opposite side

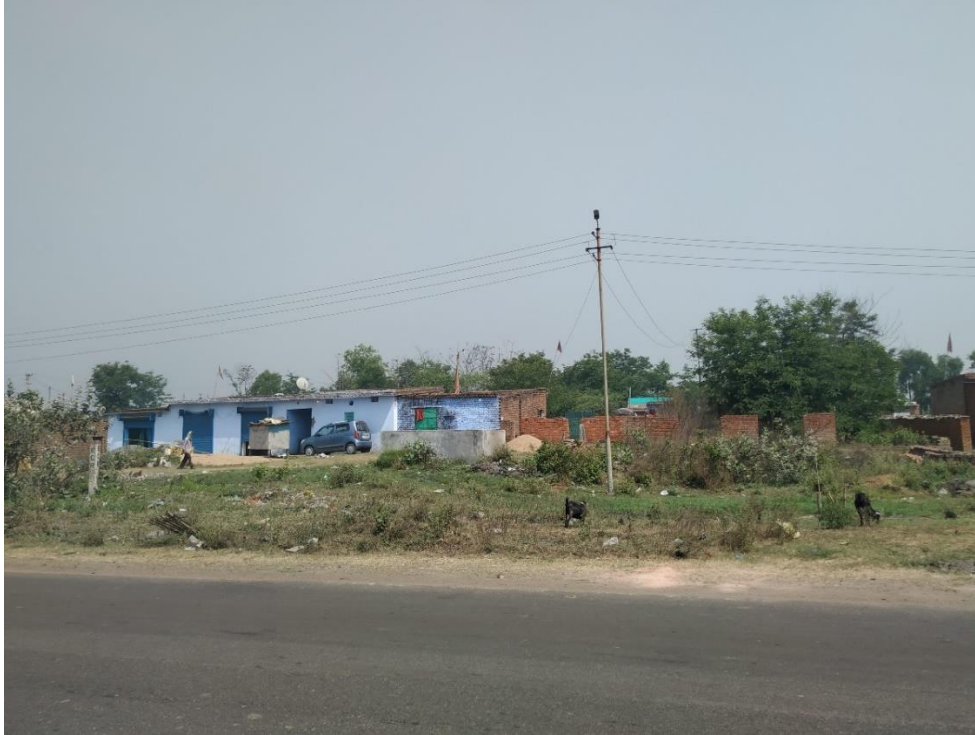
Figure 9: Bokaro OCP- Old voids of Bokaro OCP completely 'reclaimed' using ash, houses constructed on top of the filling

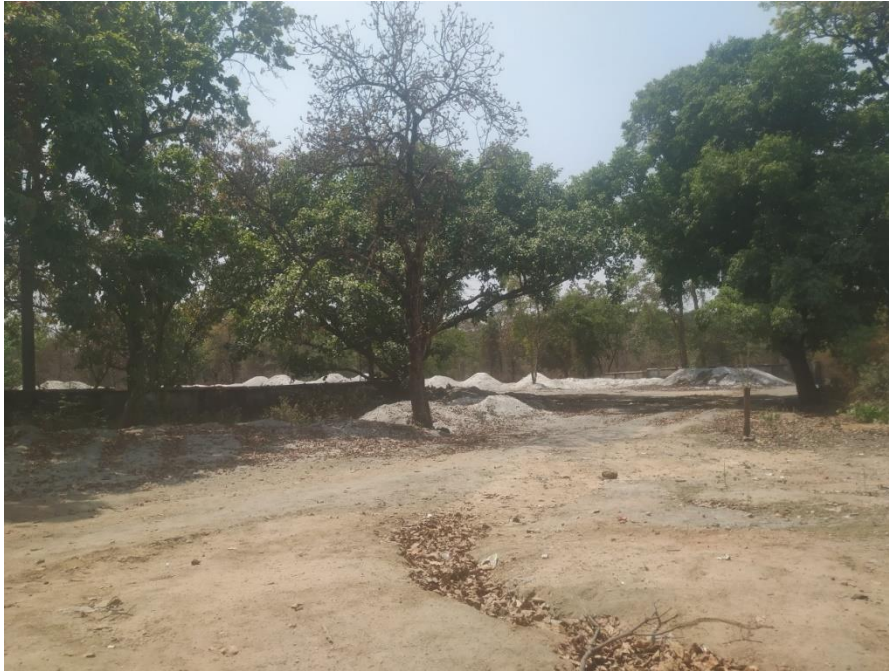
We visited a large ash dump, approximately 30 ft. in height (as estimated by us) and spread over 5.76 acres area (measured using Google Earth Pro), at a distance of about 0.5 Km from the Konar Dam reservoir boundary wall. Along the way, several small to medium dumps of flyash were also seen. The ash has been dumped on this large area and compacted, and covered with soil. Pits have been dug at regular intervals with what appears to be the intention of planting trees on this dump. According to Gulab Chandra, the ash here is also from BTPS. The way to the dump is lined with old trees throughout, and the ground below the dump (i.e., ground on lower height as seen from on top of the dump) is also covered with trees. Satellite imagery from the last five years shows dense tree cover which has been cleared to make way for this ash dump.

Figure 10: Ash dumps near Konar Dam - Several small to medium dumps can be found on roads around the Konar Dam

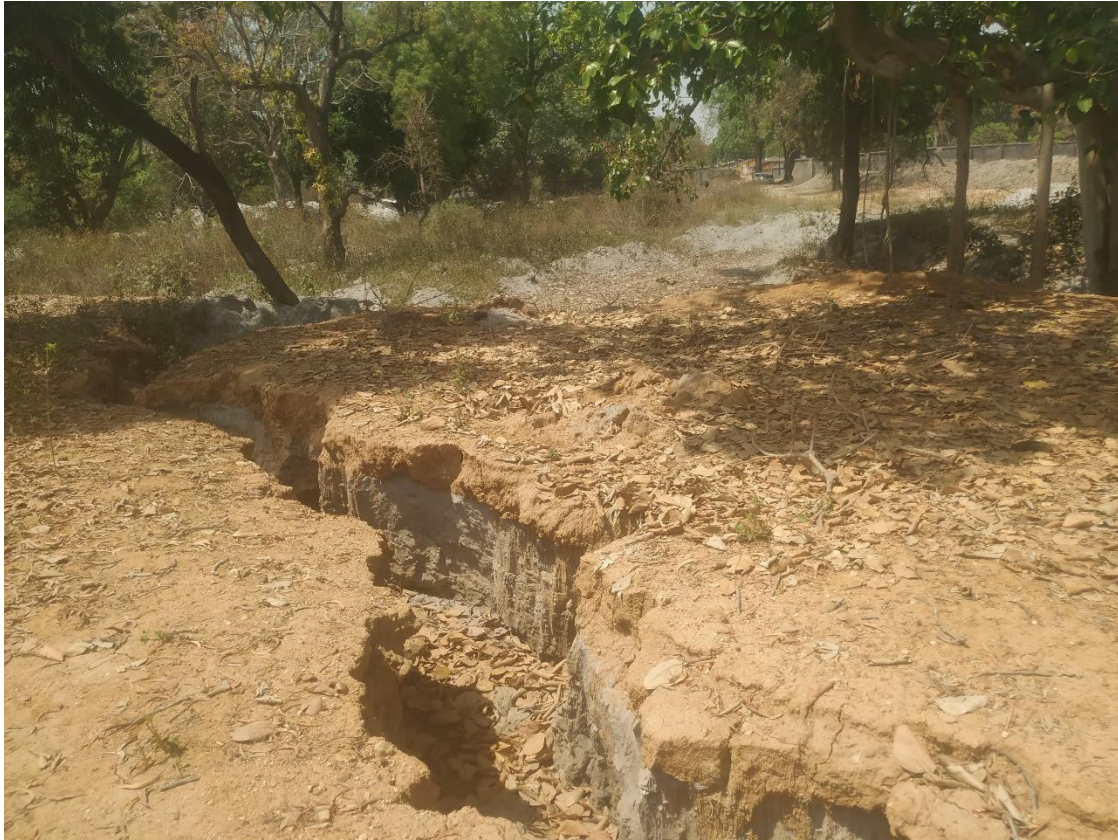
Figure 12: Ash dump near Konar Dam -Cracks in ground reveal layers of ash among layers of soil; flyash piles in the background also visible

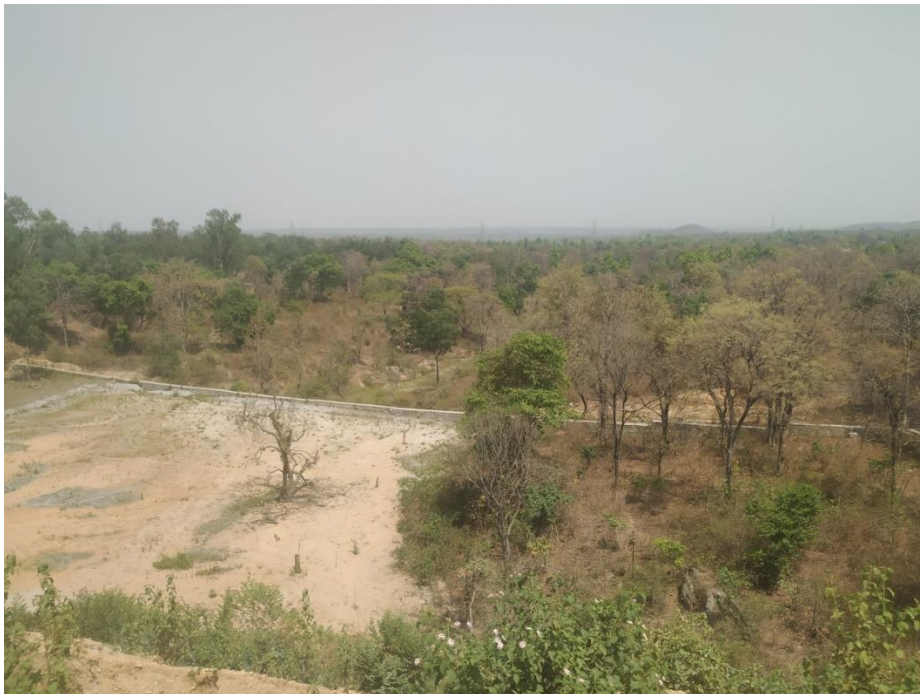
A boundary wall that has been constructed along the bottom of the ash dump possibly to preventing ash from flowing with rain water into local water bodies. However, ash that has been carried by water flow has accumulated at the wall, and it's only a matter of time before the ash laden waters will start flowing over the wall contaminating local water bodies.

Figure 13: Ash dump near Konar Dam- Boundary wall along the edge of the dump at the bottom; ash reaching the level of the boundary wall and trees in surrounding areas also visible

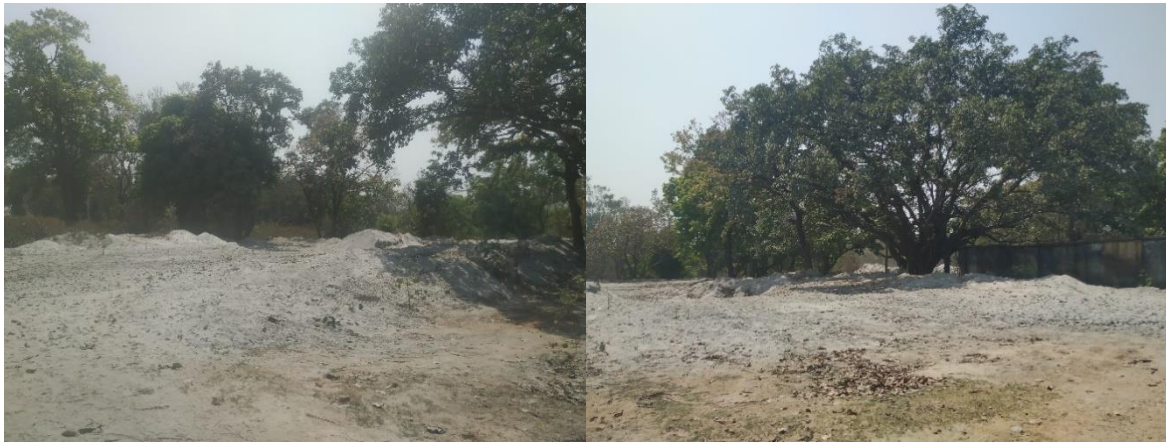
Figure 14: Ash dump near Konar Dam - Piles of ash visible around/on the way to ash dump area near Konar Dam

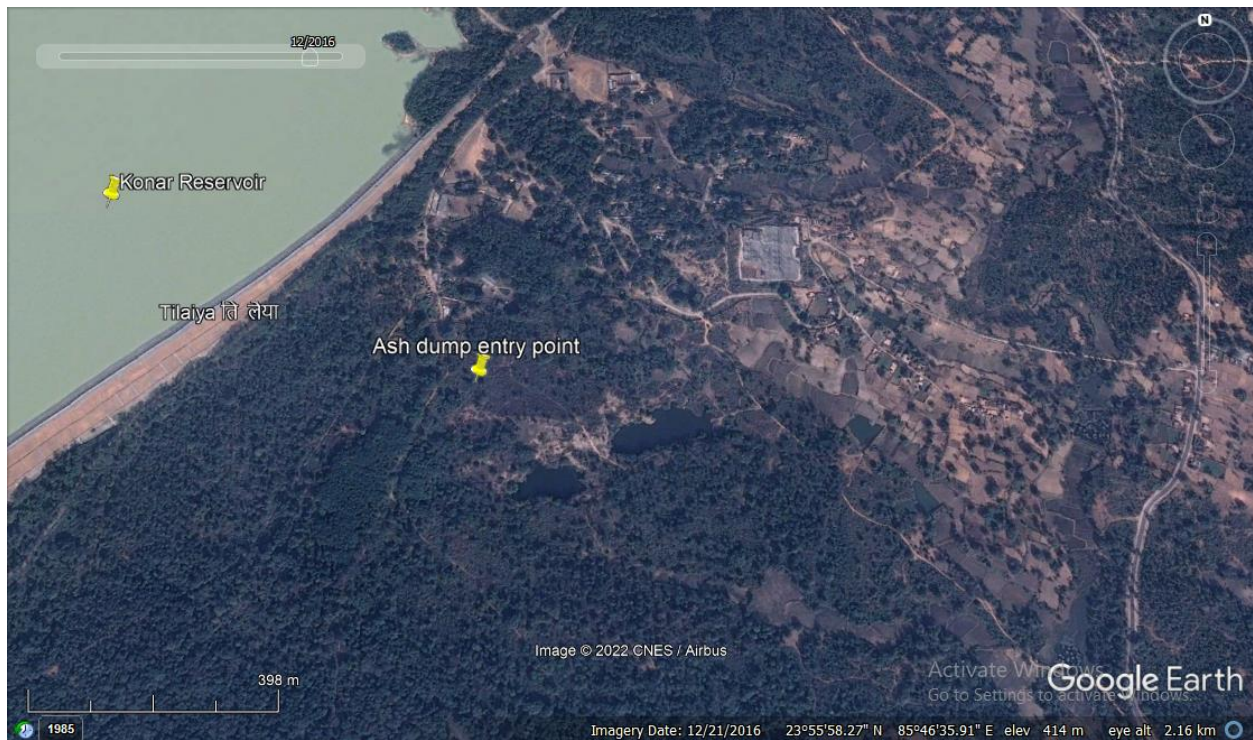
Figure 15: Satellite Image from 2016 shows dense tree cover

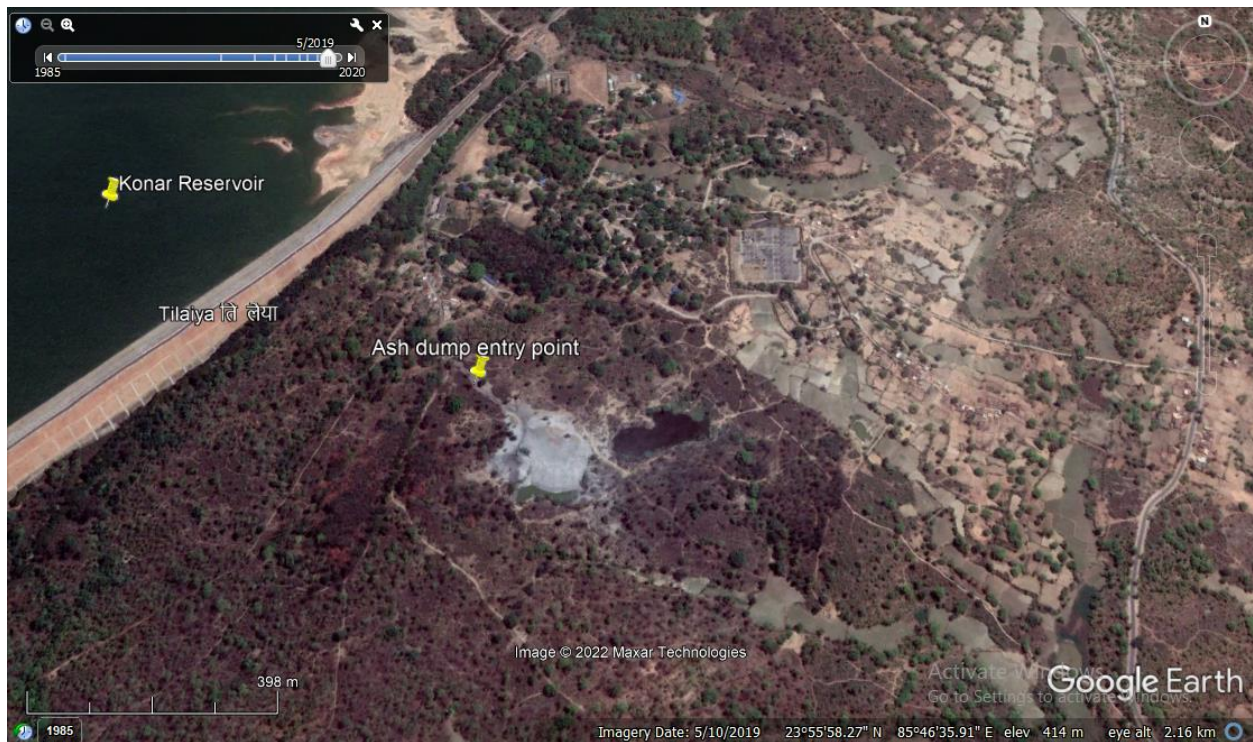
Figure 16: Satellite Image from 2019 shows large ash dump

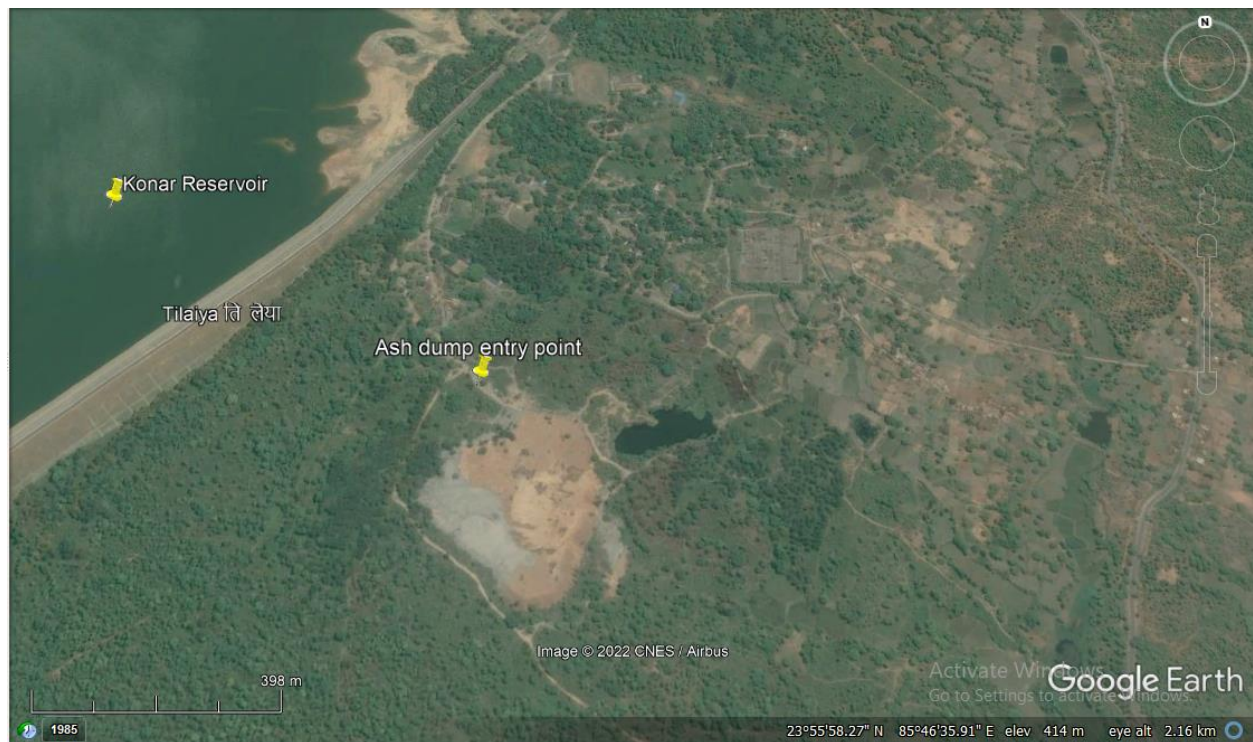
Figure 17: Satellite image from 2020 shows ash dump increase in size

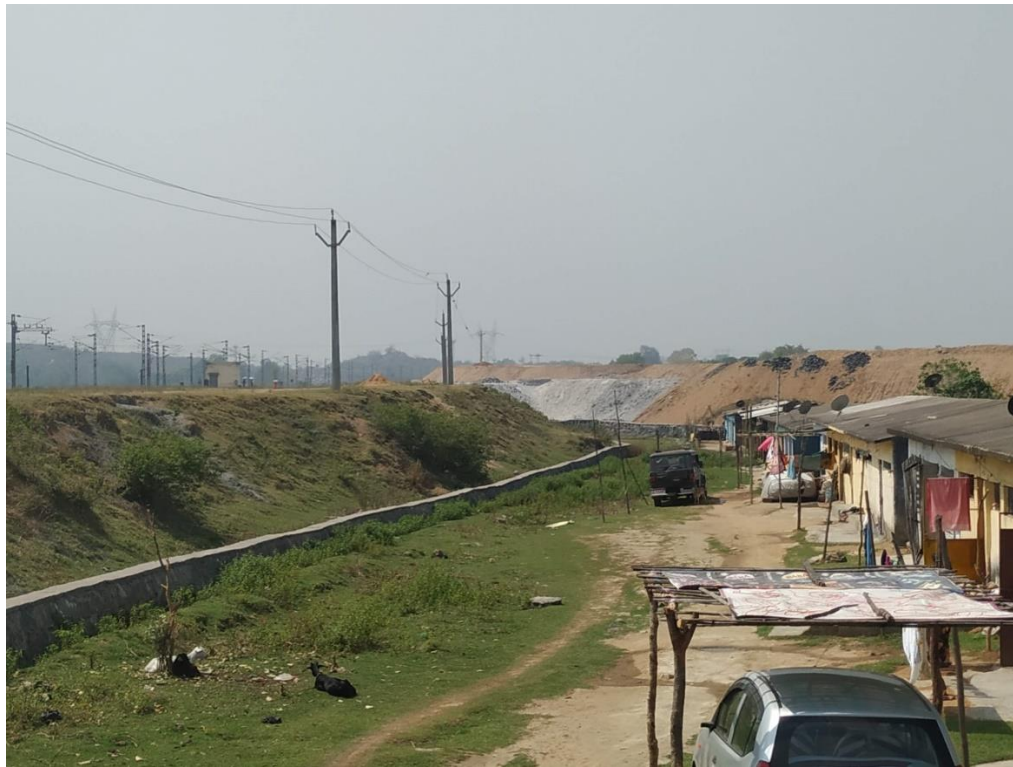
A settlement named *Jhari basti*, located along the railway tracks passing through Lalpaniya, is surrounded by large ash dumps. The dumping has been done in what is called 'low lying area' by the plant authorities, and appears to be dumped over several years. Where previously people cultivated crops, now there is grass, on land raised about 25- 30 feet above 'ground' level – essentially large dumps of ash covered with soil. Old ash dumps covered with layers of soil can be seen on either side of the railway tracks, and are less than 1 Km from residential buildings.

Figure 19: Tenughat Low Lying area ash dumps - Flyash and soil covered ash dump visible near residential buildings

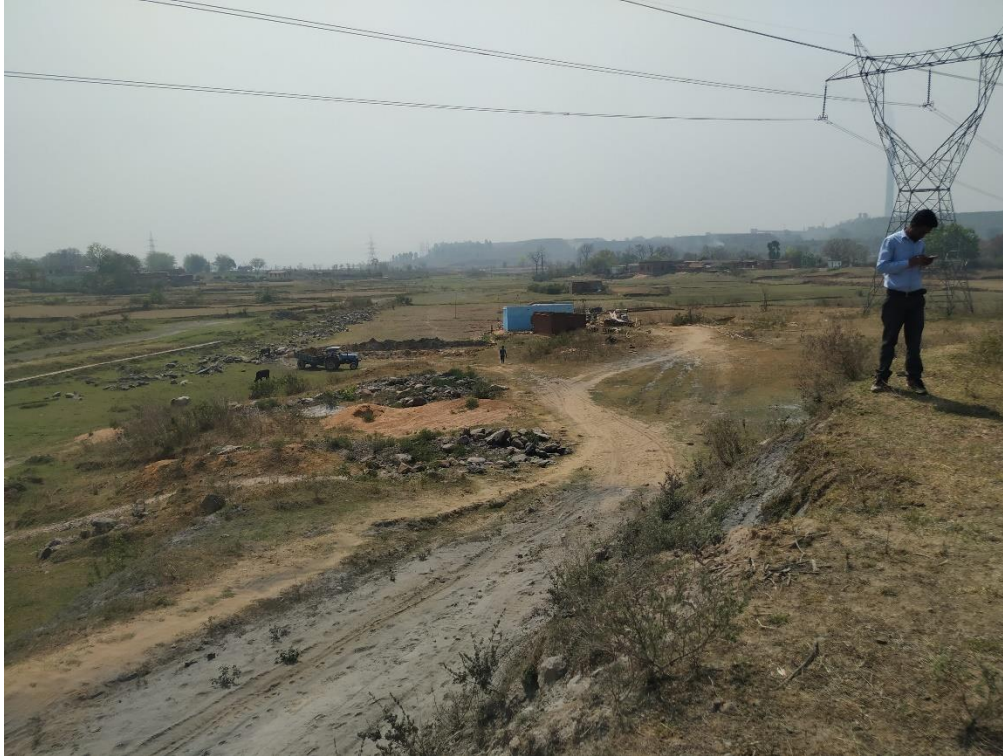
Figure 20: Tenughat Low Lying area ash dumps - Ash laden road on the way to Jhari Basti; photo taken from on top of ash dump

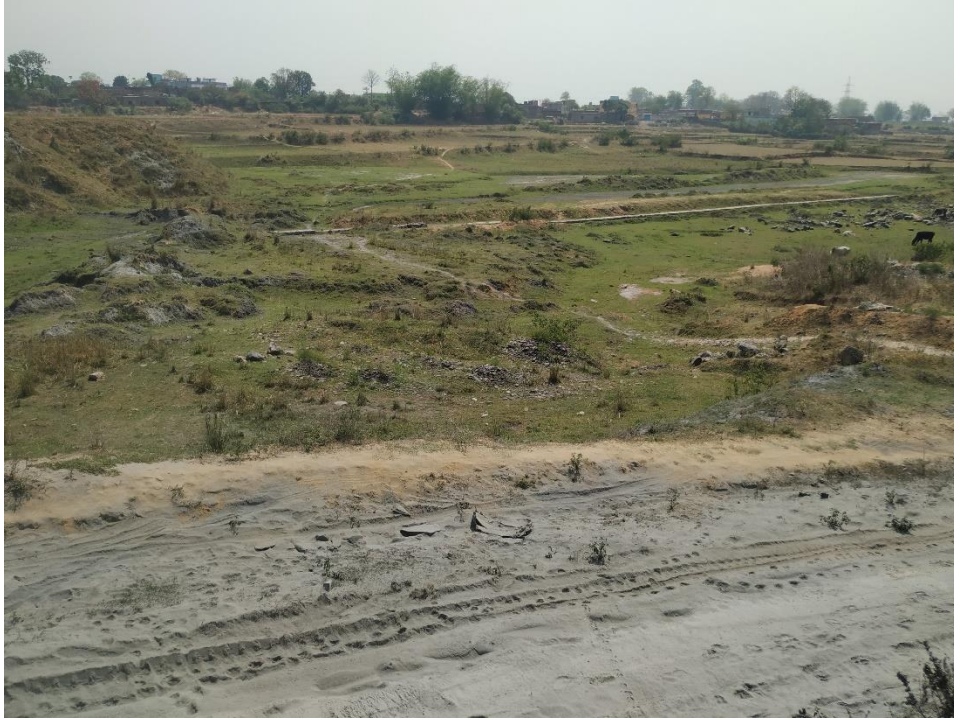
Figure 21: Tenughat Low Lying area ash dumps-Ash routinely covers the grazing land in vicinity of Jhari Basti

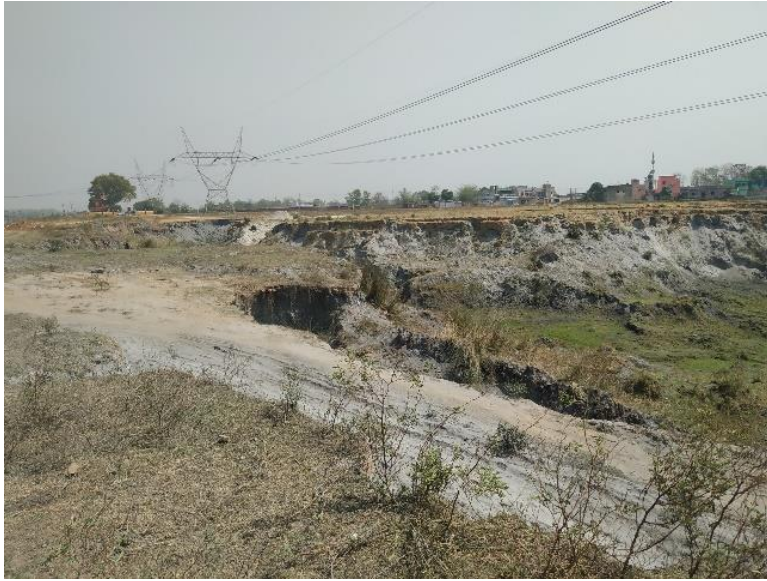
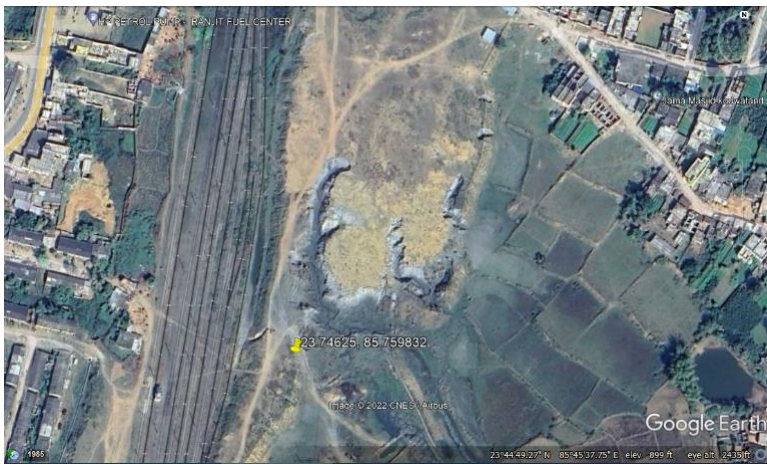
Figure 23

Figure 22: Tenughat low lying are ash dumps - Photograph of large ash dump near Jhari Basti above; Satellite Image of same ash dump below (Figure 22)

Most importantly, the sub-committee had recommended that all ash dumped in open areas be removed immediately. However, over four years after the recommendation of the sub-committee report, excessive flyash dumps in surrounding areas remain as they are, as observed by our team.

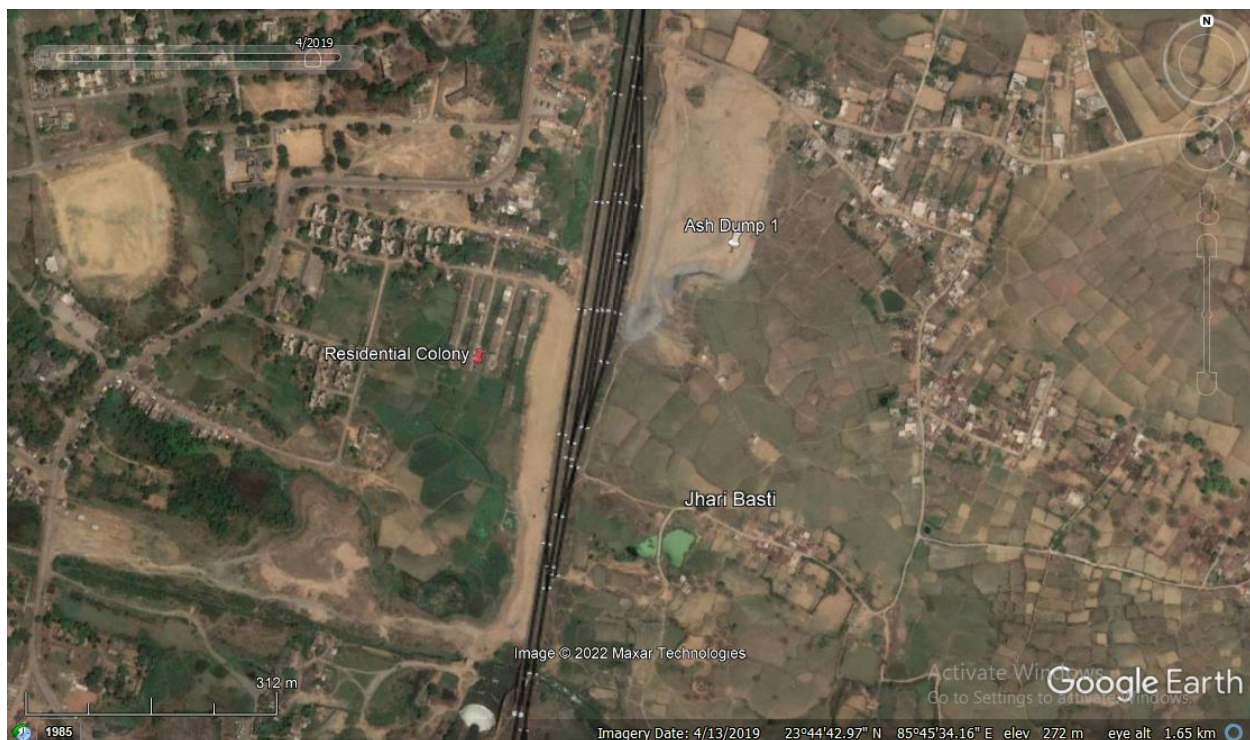
Figure 24: Satellite Image from 2019 shows ash dump visited by us

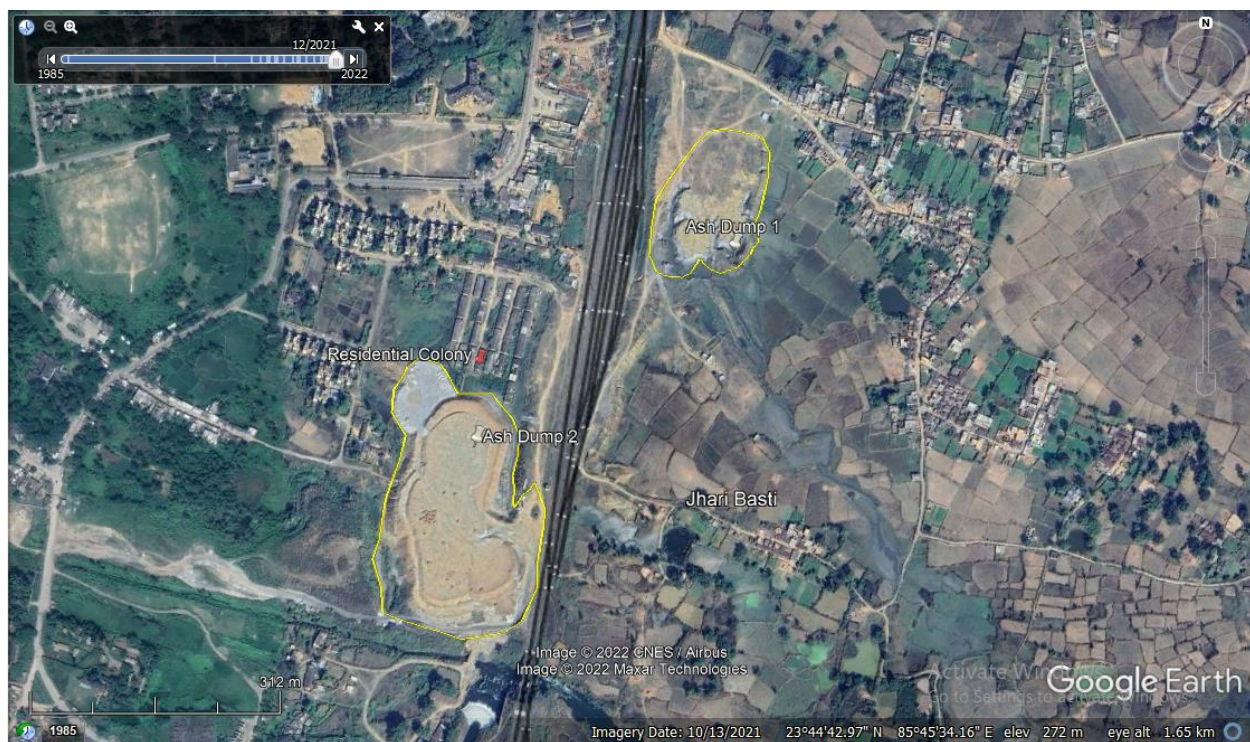
Figure 25: Satellite Image from 2021 shows increase in area of ash dump as well as another ash dump in the vicinity

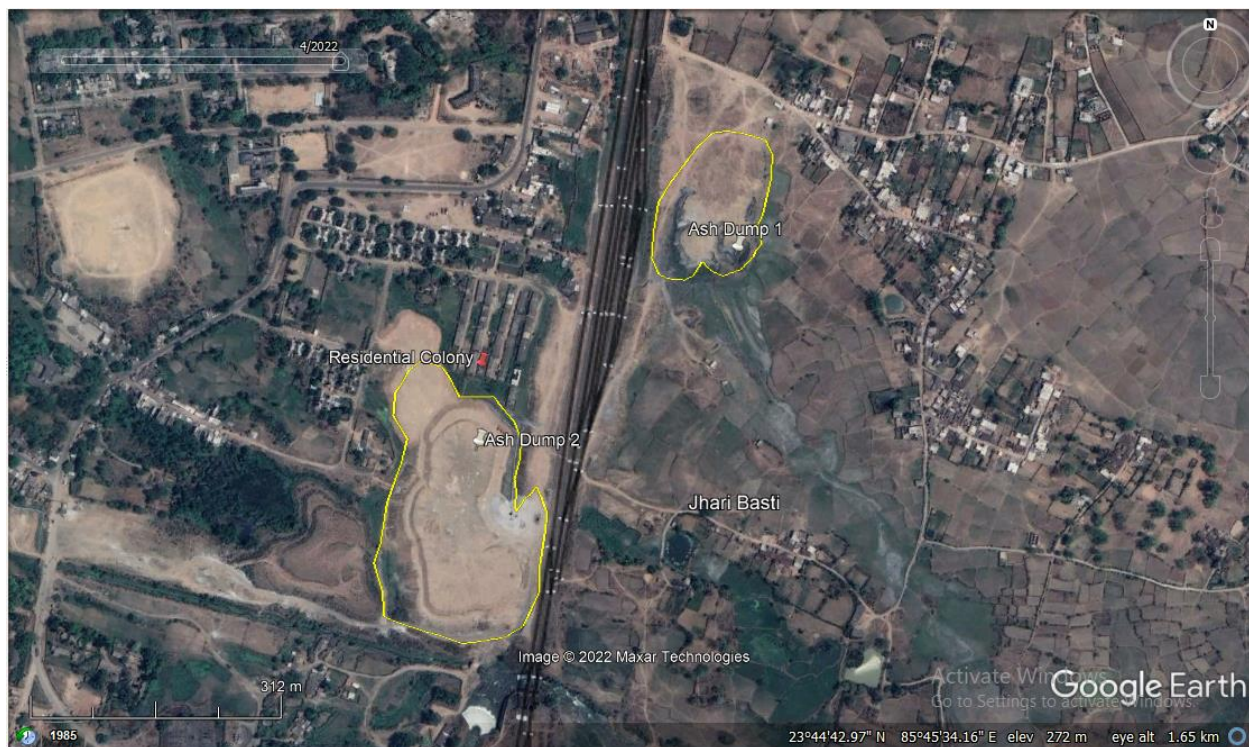
Figure 26: Satellite Image from 2022 shows spread of the ash dumps and proximity to residential colony and Jhari Basti

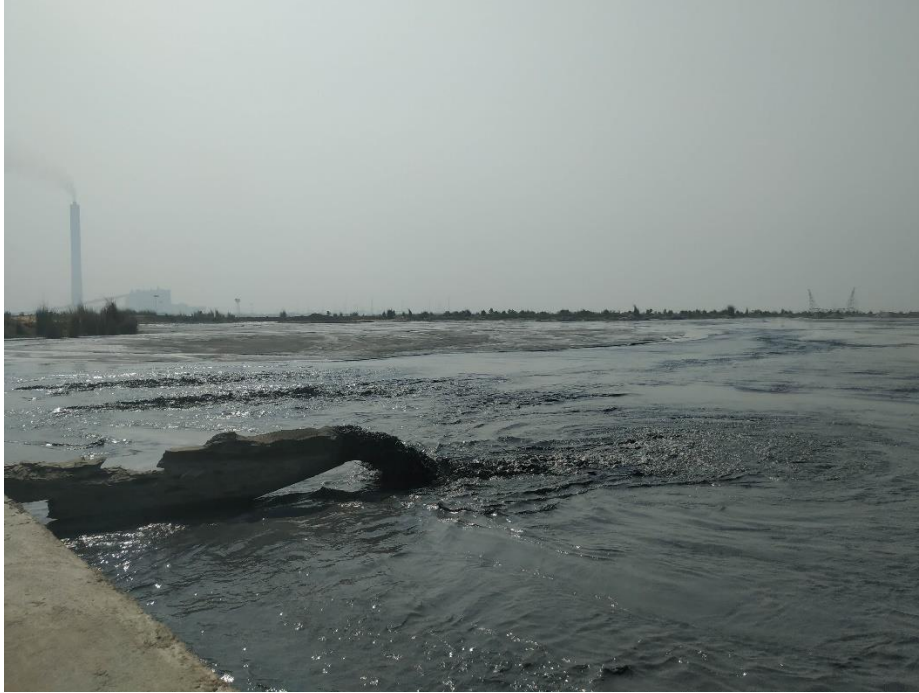
The team also visited the TTPS ash pond. We found ash slurry being disposed of in the ash pond in one part. At another part, we also saw pond ash being removed and taken away in trucks. We were told that this ash is being taken to be disposed in the dumps like the one which we had visited, as there is no space in the ash pond for more ash if existing ash dumped here is not removed.

Figure 27: TTPS Ash Pond - Ash slurry flowing into pond, TTPS chimney visible in background

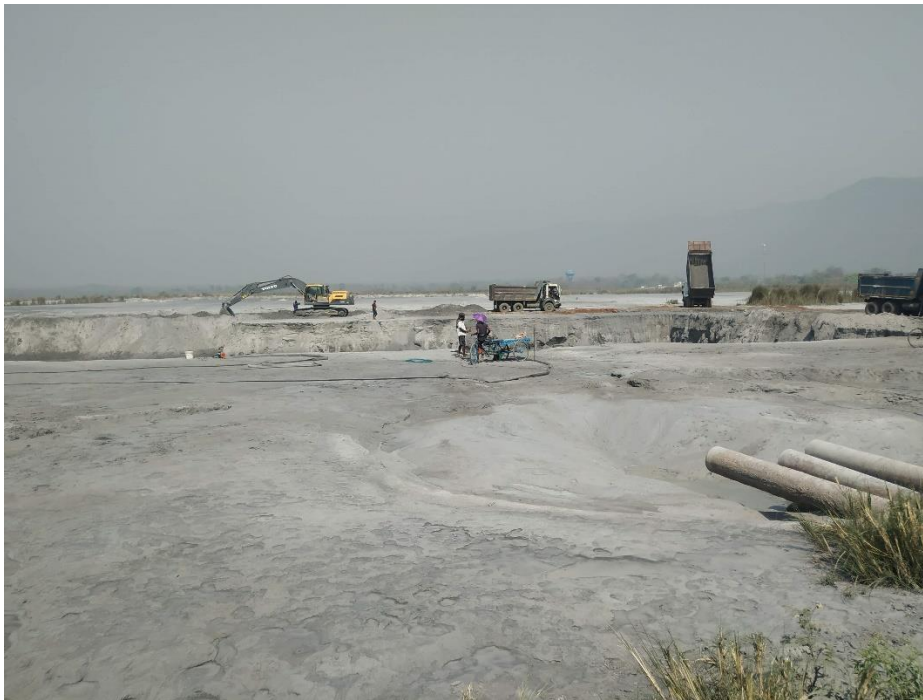
Figure 28: TTPS Ash Pond- Trucks stationed for loading with flyash at one section of ash pond

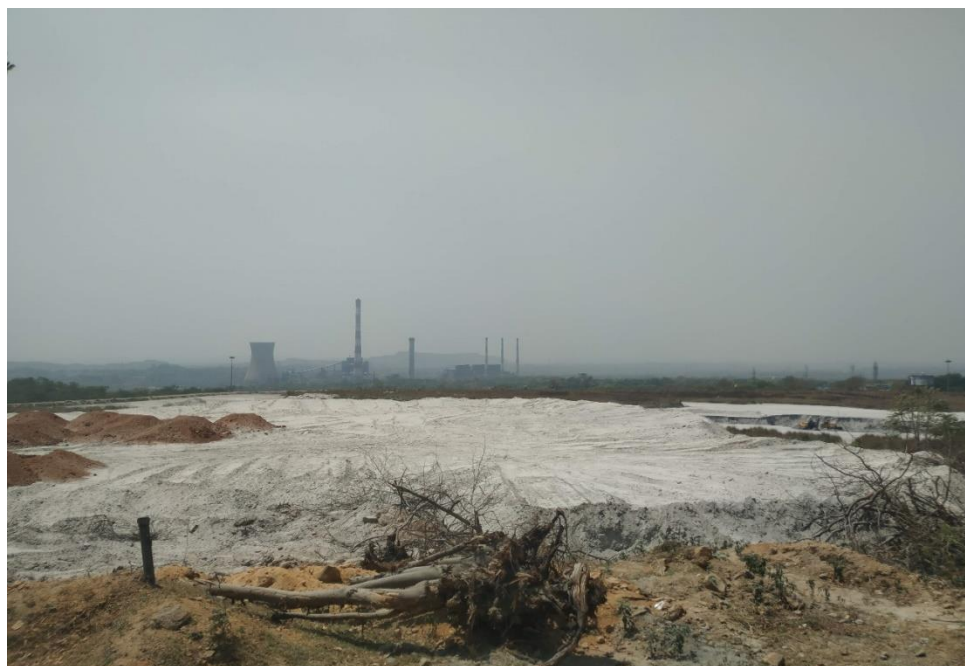
The ash pond of Bokaro Thermal Power Station breached in September 2019 flooding 20 DVC quarters and nearby farmland with ash slurry. We spoke with locals in Bazar Tand, and a senior villager told us he had still not been compensated for the damage caused by the ash slurry breach to his standing crop (rice). Parts of his agricultural land, and that of several others cannot be used like it was before, as it was not adequately cleaned in the aftermath of the breach – all this over two years after the incident occurred. The locals mentioned that ash carrying trucks pass through their village throughout the day, covering the terraces of all homes in a 1 inch layer of ash. Even though they clean their houses in the morning, by the evening, the house floors and insides also get covered in ash.

Figure 29: BTPS Ash Pond - One section of ash pond with BTPS visible in background
